# MCCOY STADIUM Study

January 26, 2017

Pawtucket, RI

## FINAL REPORT

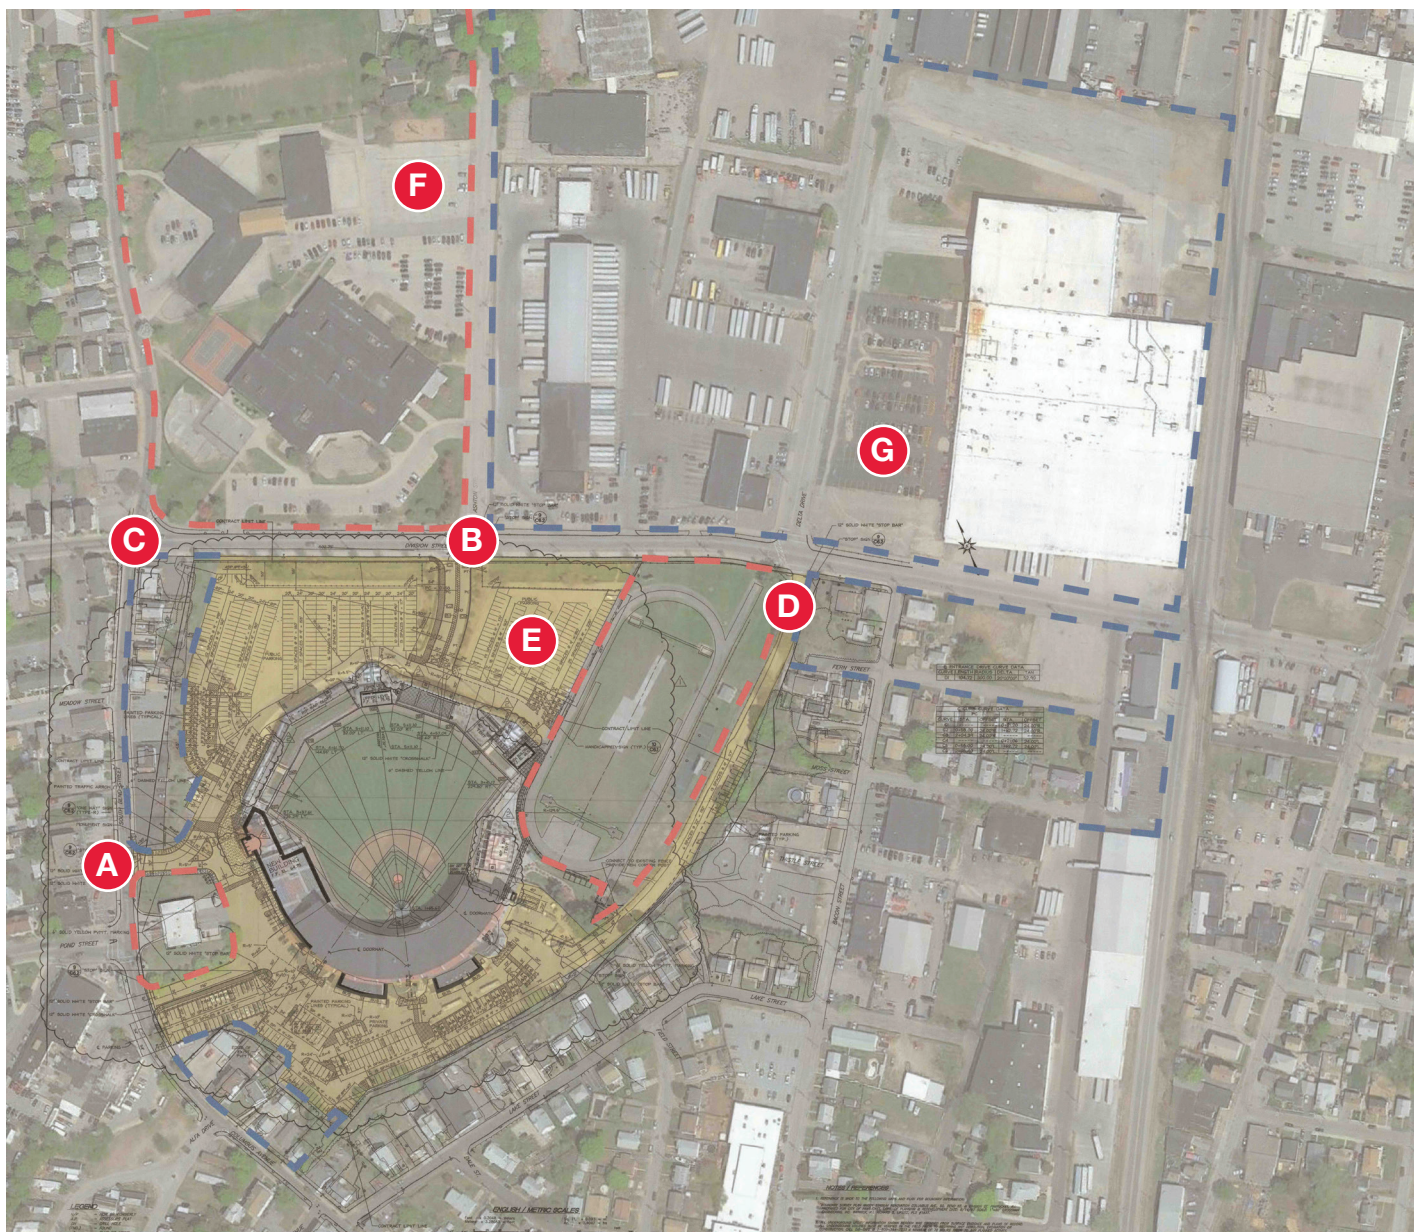
Fig. 015. Site Plan

- The games with fireworks have the highest attendance (typically 7,000 - 8,000 patrons).
- After the stadium parking lot is filled, vehicles are directed to the school parking lot at the corner of Division & Ashton Street. Parking here is free **(F)**.

- After the school lot is filled, the factory at Division and Delta Drive is used **(G)**; there is a charge to park in this lot. An attendant collects payment at the entrance. Stadium staff have a key to the gate. Drivers are instructed to not park in employee spaces.

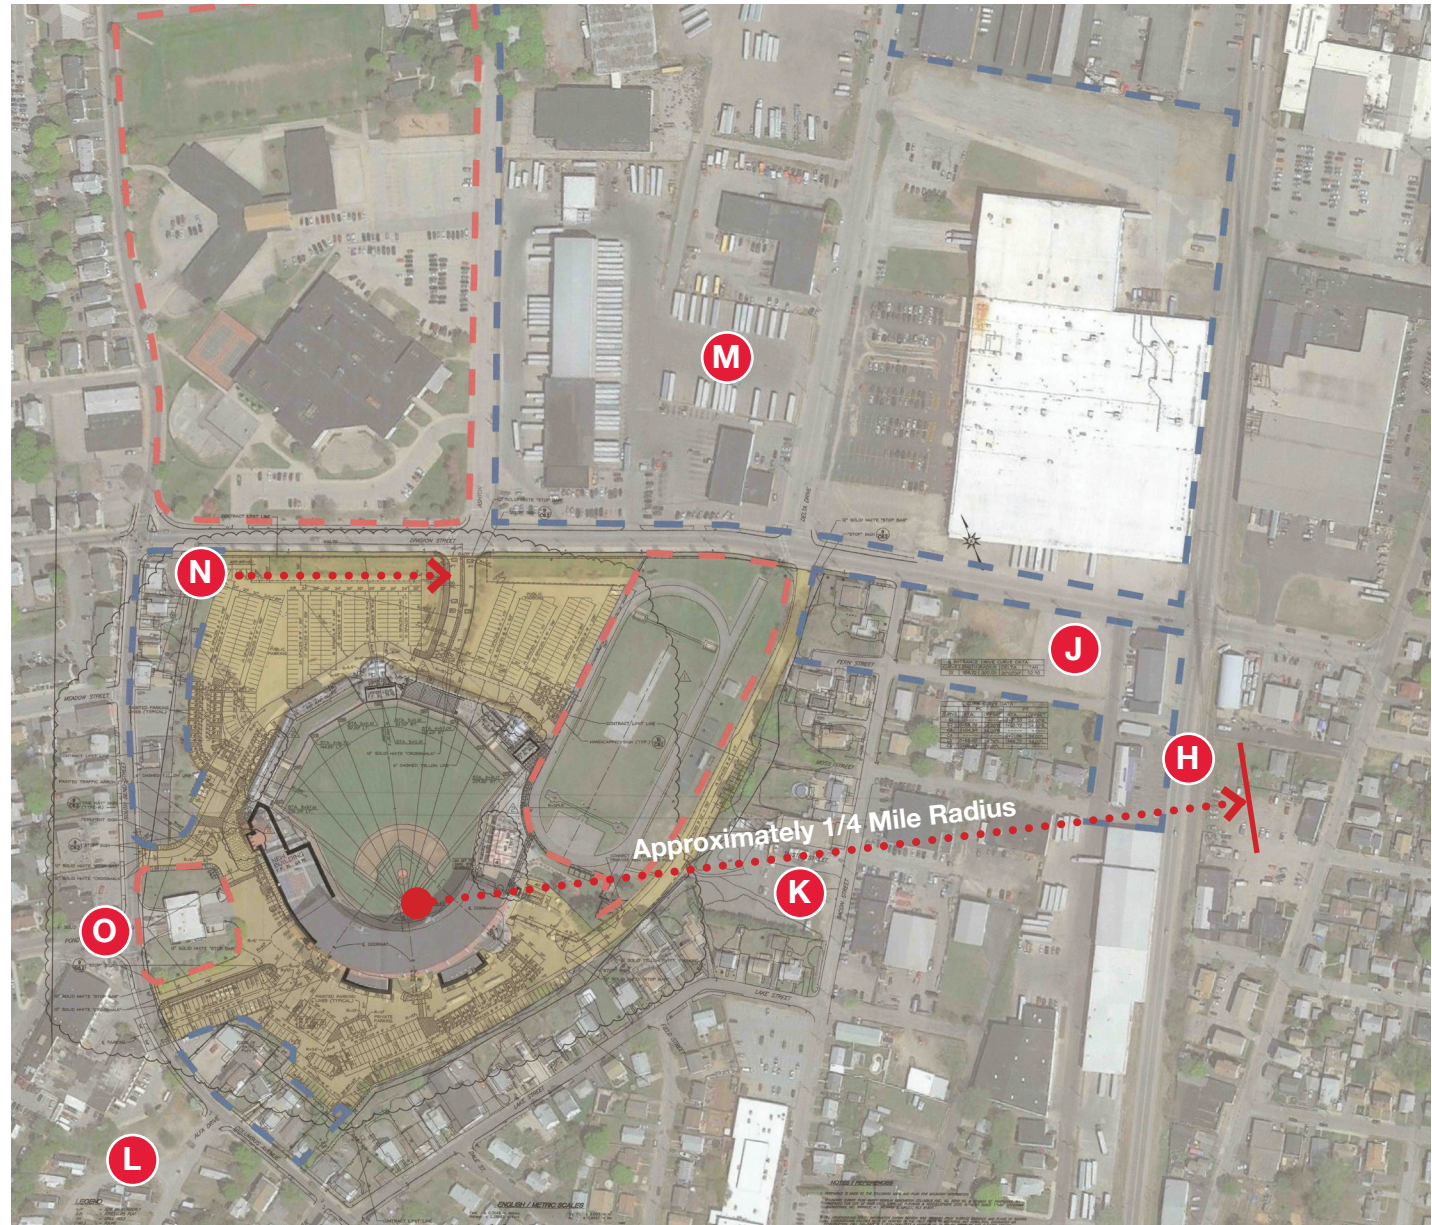
Fig. 016. Site Plan

- Division Street can back up during high turnout games. For these games the staff line up traffic cones along the curb to prevent on street parking. **(N)**. Prior to game time they adjust the cones to facilitate two lanes. (Two lanes on Eastbound approach).

- The South Bend Street & Pond Street intersection **(O)** experiences some congestion during higher turnout games.
- Attendance was approximately 4,000 on the night the design team attended. Traffic was observed to be operating efficiently with minimal congestion.

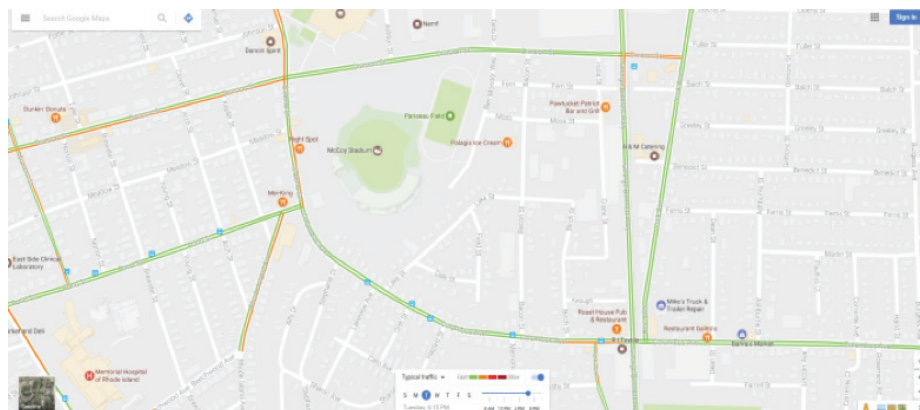
Fig. 017 Google Map of Area

Figure 017 shows a Google Maps representation of typical traffic on a weekday at the hour of 6:00 PM. The figure represents traffic on a non-game day and therefore only addresses background volumes. Segments shown in green indicate no delay. Those shown in orange experience a medium amount of traffic. Segments shown in red would be experiencing delay, although there are no such areas in the McCoy Stadium area at this time on a non-game day.

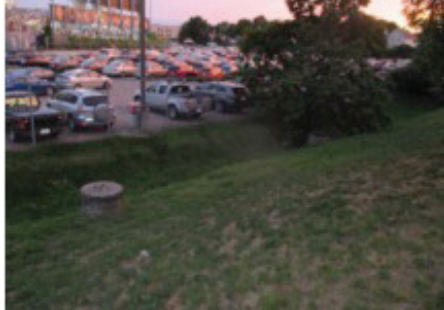
Fig. 018. Sample Catch Basin/Yard Drains

McCoy Stadium is located in a "bowl", with the adjacent streets and properties at a higher elevation draining into the site. There is an existing grass swale that runs easterly along the north side of the property along Division Street. The swale discharges into a system of catch basins/yard drains. (Fig. 018). This system appears to be operating sufficiently (although not observed during a rain event).

- Conduct a thorough inspection of the drainage system.
- Collect background data and mapping of the existing system, including the City's culvert.
- Conduct a subsurface soils investigation (test pits, borings, etc.) including soil permeability tests to determine the potential for subsurface infiltration of storm drainage runoff.
- Prepare geotechnical report outlining proposed pavement sections.
- Perform field survey of the existing site, including the storm drainage system upstream and downstream of the site.
- Perform drainage analysis of the site and field drainage systems.
- Prepare a report of the system deficiencies in the existing system based upon the collected data and make recommendations for repair options.

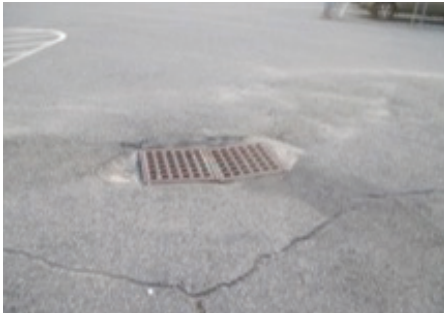
Fig. 019. Sample Deteriorating Basin

The existing storm drainage collections system in the parking areas has not been maintained. The basins were full of sediment and debris when observed. The structures are in disrepair and failing (Fig. 019). There are areas of puddling in the unpaved sections of the parking area that create ongoing issues with pedestrian and vehicular traffic (Fig. 020).

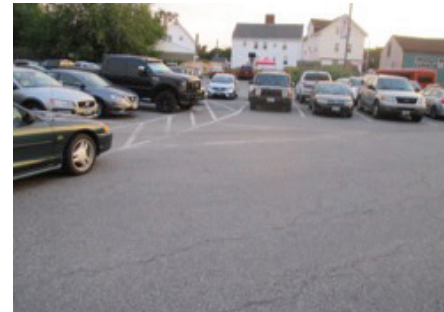
Fig 022. Example of Typical Pavement Cracking

The existing pavement on site is in fair to good condition. There are areas of significant cracking (*Fig. 022*). However, large scale pavement failures were not observed.

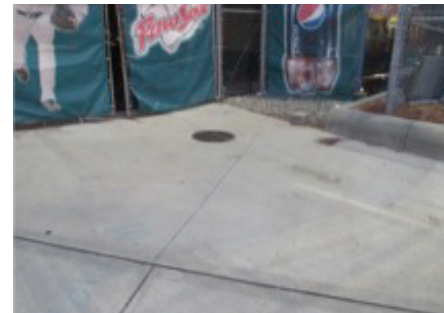
Fig 024. Fairly Recent Concrete Sidewalk/Paving

The concrete sidewalks immediately adjacent to the stadium appear to have been recently repaired/replaced and are in good condition (*Fig. 024*). The concrete walks entering the site from Columbus Avenue also appear to be in good condition. However, the bituminous sidewalks accessing the site from Division Street are in very poor condition. In consideration of the fact that Division Street acts as the main pedestrian way, the aforementioned poor conditions presents operational issues and potential safety hazards to the operator and stadium owner.

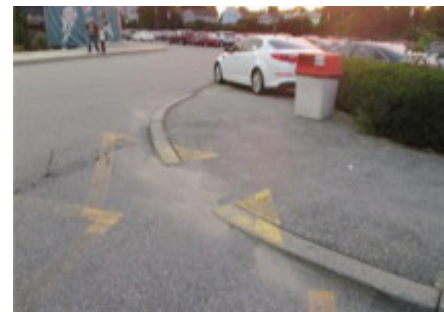
Fig 026. Example of Missing/Deteriorated Striping

The site should be reviewed for conformance with ADA requirements. It was observed that many of the ramps and walkways do not meet the current ADA guidelines, in terms of grading, width of travel way, etc. Crosswalks and other striping and signage are required for the safe passage of pedestrians throughout the site. (*Fig. 025 & Fig. 026*).

- Conduct a thorough review of sidewalks and pedestrian travel paths.
- Review site survey with an emphasis on pedestrian access and ADA compliance.

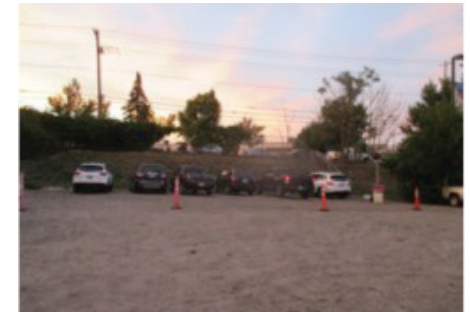
Fig 023. Example of Non-Paved Parking

The parking area at the northwest and northeast corners of the site are not paved. They are graded poorly and have inadequate drainage, causing large puddles that last a significant amount of time due to the soil being overly compacted. Also, due to the lack of pavement, any pavement markings are quickly eradicated. This causes the need for facility staff to direct the parking of vehicles during games in order to maintain aisles for the safe maneuvering of vehicles and pedestrian travel (*Fig. 023*).

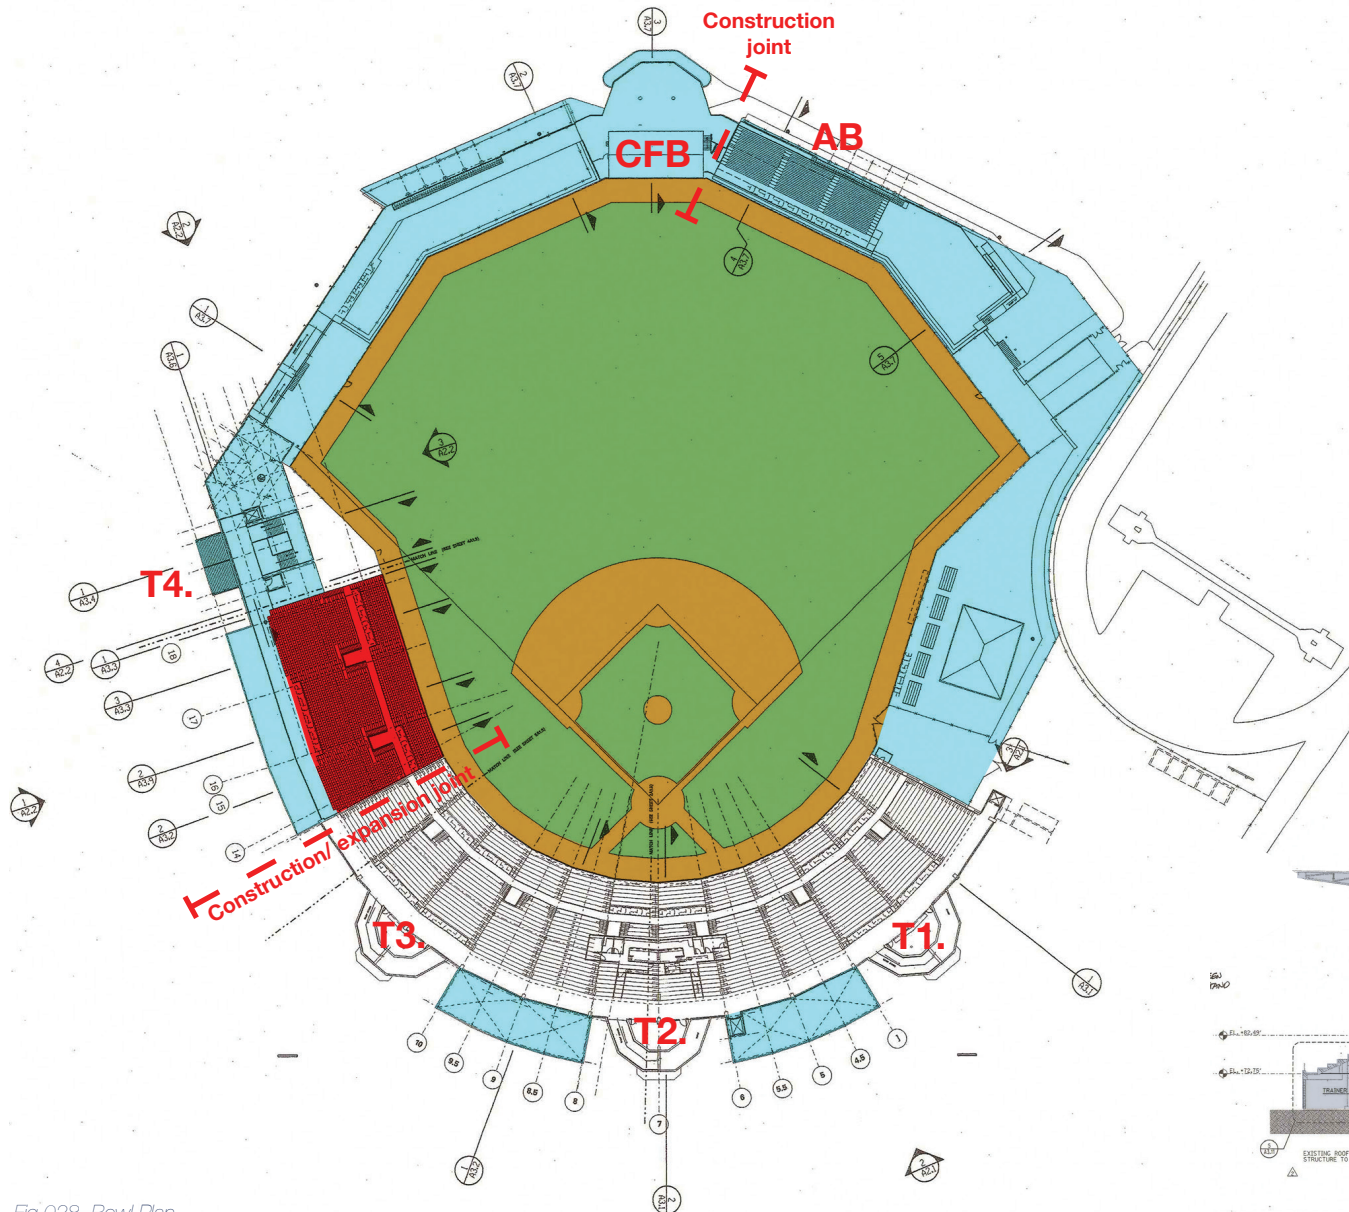
Fig 029. Building Section

The original structural system of McCoy Stadium consists of concrete columns bearing on pile caps, a combination of concrete raker beams and steel trusses supporting the main seating bowl behind home plate, and a steel truss supporting a tongue and groove wood roof (see Fig. 029 section cut - shaded area designated 1942).

In 1999, a separate structure behind home plate was added that consists primarily of a load bearing masonry exterior facade and an elevated slab supported by steel beams, columns, and spread footings. The upper TPO roof over the new outboard concessions stands are supported by steel bar joists - (see Fig. 029 section cut - red lined area designated 1999).

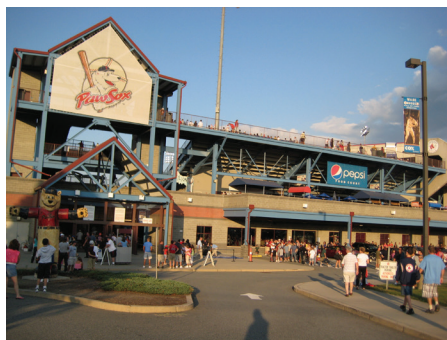
Fig 030. McCoy Main Entry

Tower 4 (T4) was added in the 1999 renovation and is currently used as the primary entry point for patrons entering and exiting the stadium. The structural system consists of steel columns and horizontal beams with a gable roof structure framing the main entry portal.

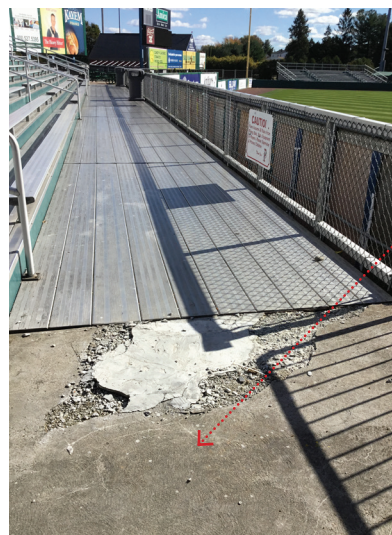
Fig. 031. Bleacher Construction Joint

The uneven and deteriorated pavement at this location is not in compliance with local code that calls for no more than 1/2" differential between adjacent surfaces on an accessible and/or pedestrian route. As can be noted from the picture taken during our investigation (Fig. 033), there have been attempts to patch this area, however the damage caused by corrosion associated with recurring water infiltration at this location has resulted in a tripping hazard for patrons who visit the stadium and employees who work there. More investigation is needed to determine the source of the problem; however, based on the information we have now, we conclude that the installation of an

area drain at this location that discharges to the storm drainage system coupled with the replacement of the damaged slab with a new concrete surface with positive drainage will be helpful. While the structural steel that supports the concrete slab is exposed, investigation into the presence of additional rust and corrosion should be carefully considered to determine if the structural integrity of the overall assembly has been compromised.

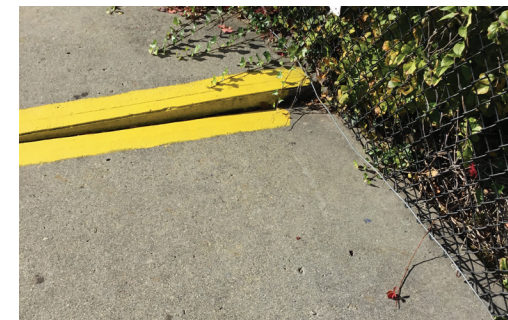
Fig 032. Uneven Pavement Exceeding 1/2"

There are numerous examples along the pedestrian route within the secure line of the stadium where uneven pavement presents a tripping hazard to patrons and a threat of liability issues to the tenant and owner (Fig. 032, Fig. 033). The overarching structural concern we have on all counts is the presence of water that may be at the root of the cause of settlement.

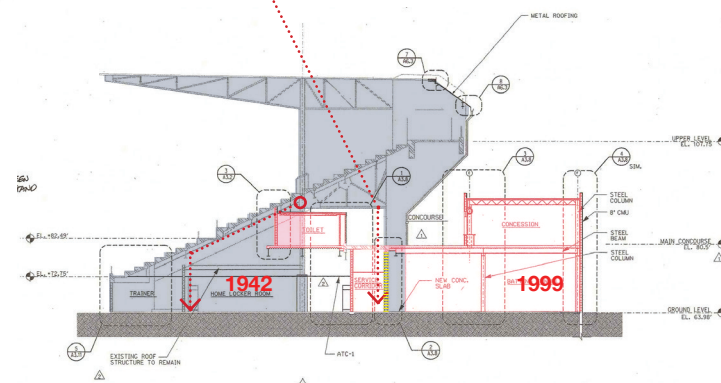
Fig 036. McCoy Building Section

1 BUILDING SECTION @ SADDLEBAG

Note stained ceiling tile  
indicating presence of  
water at this location

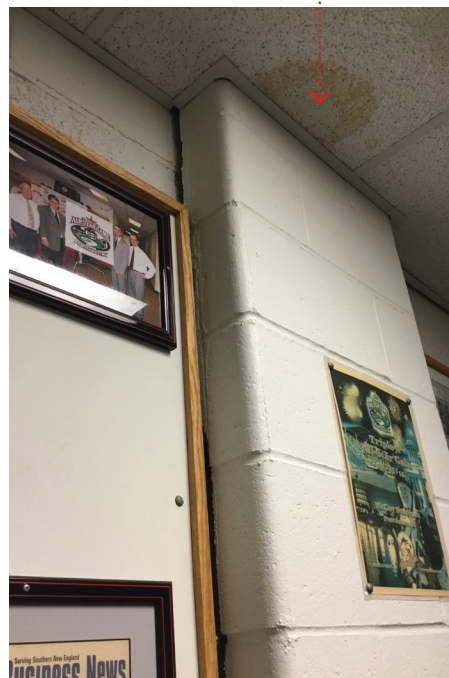
Fig 038. Example Of CMU Wall Movement

specifically at the new concrete masonry unit (CMU) party wall that transitions the 1942 building to the 1999 building (Fig. 038, Fig. 040). As noted by the red arrow in the corridor wall with major shifts and cracks in it (Fig. 039), we observed a significant dip in the concrete slab. This leads us to believe that there is either water accumulating beneath the slab thus compromising sub-grade bearing capacity of the soil and/or the compaction of the soils at this location never reached the appropriate levels to withstand the load of the 1999 new walls. The structural document in Fig. 035 suggests that grade beams were not called for or constructed at this and other similar locations.

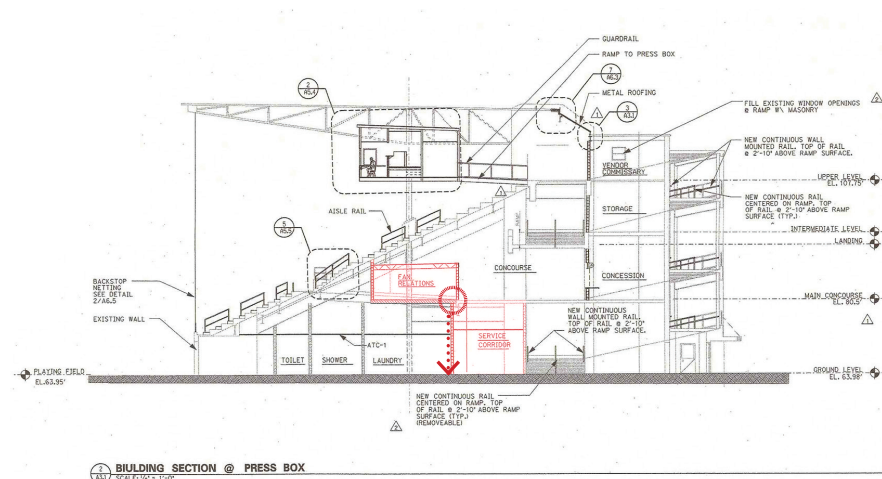
Fig 041. McCoy Building Section

The building section shown in Fig. 041 illustrates an example of a potential weak point in the 1999 structure. The transition between the interior and exterior slab assembly, the CMU wall bearing above a cast in place beam, combined with the lack of positive drainage of the exterior slab seem to be allowing water infiltration down the CMU wall at the playing field level resulting in the conditions we see illustrated in the photographs above (Fig. 038, Fig. 039, Fig. 040). The building section suggests that a topping slab sloped to drain was scheduled at this location. Further exploratory investigation is required to confirm the existence of a fluid applied membrane. If one exists, the fix could be as simple as repairing the membrane where the slab meets

the load bearing wall. If a fluid applied or rubber membrane was not applied beneath the topping slab we recommend a complete demolition of the topping material and the installation of a continuous self healing-fluid applied membrane and a new concrete topping slab sloped to drain with a continuous elastomeric coating. Although this may seem like a "belt-and-suspenders" approach, it is the only way to increase the probability of avoiding future water infiltration into finished spaces below.

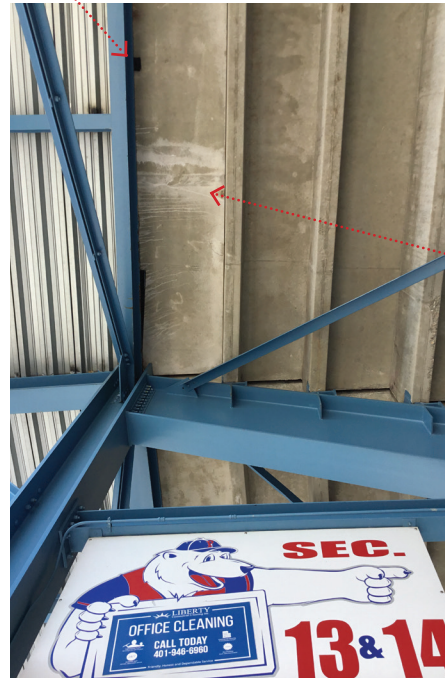
Fig 042. Example Of Shifting Structure

Shifts in the structural frame has caused precast shims to fall to the ground involuntarily - this is an example of a shim working its way out

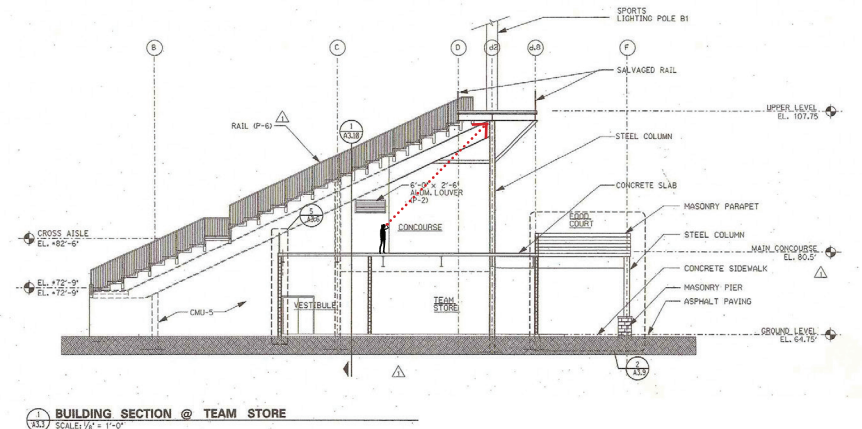
Fig 044. McCoy Building Section

Corrosion/rust most likely caused by improperly grouted railing, allowing water infiltration and damage to load bearing structure below

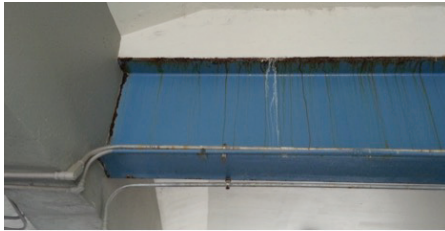
Fig. 045. Tower Ramps - Steel Beam Corrosion

We observed evidence of corrosion in numerous locations throughout the stadium, which leads us to believe that water infiltration is the number one priority for slowing down the aging process of the building as it relates to useful life over the next twenty years. The areas of immediate concern as it relates to life-safety are items that if allowed to further deteriorate could fail in time. Fig. 045 and 046 illustrate load bearing conditions where structural failure could result in loss of life. These and like conditions should be given immediate attention.

No.	Item	Unit	Qty	Cost	Total Cost
1.12A	Steel Corrosion Repair	TON	692	\$630.00	\$435,960.00
1.12B	Steel Prime & Paint (TNEMEC)	TON	692	\$450.00	\$311,400.00

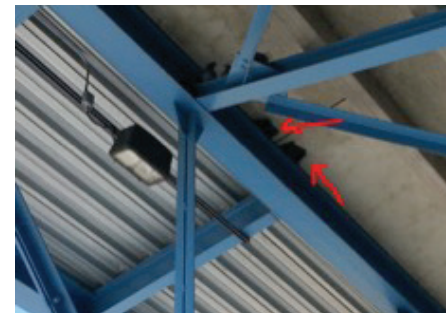
Fig. 050. Shims Involuntarily Moving

It is clear from our investigations that the 1942 structure seems to be shifting/moving at a different rate than the elements added in the 1999 renovation. The images on the right (Fig. 042, 043) are examples of conditions observed in numerous locations beneath the 1999 seating bowl. Shims that are typically used to level the precast seating sections have started to involuntarily work their way from the space between the structural steel frame and the precast concrete seating. Sizable chunks of precast concrete are also falling to the concourse in a number of areas where once again it seems that corrosion due to water infiltration has deteriorated portions of the structure. This condition is of immediate concern because it presents a safety hazard to patrons visiting the stadium. If a chunk of spalled concrete were to break loose and strike a patron on the head (similar to the case in Chicago at Wrigley Field), there could be significant liability issues facing the owner of the stadium. Fig. 044 illustrates the typical location we encountered spalling concrete in the 1999 portion of the renovated stadium. One can conclude from the typical location of the damage at the intersection of slab and beam at the top of the bowl that positive drainage is not being achieved at this location and therefore the steel frame is deteriorating from corrosion.

1.12C	Repair Precast Bearing - Replace Shims	LS	10,060	\$2.50	\$25,150.00
1.12D	Replace Seating Bowl Railings	LF	3,720	\$110.00	\$409,200.00
1.12E	Frame Reinforcement - Shifting Structures	TON	25	\$2,800.00	\$70,000.00

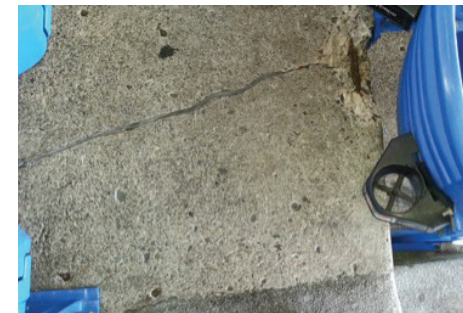
Fig. 051. Cracking & Exposed Rebar With Rust

Fig. 048 will be discussed in greater detail in Section 1.33, but it is important to keep in mind that exposed and rusting rebar currently present in the seating bowl could also provide water infiltration into the structural slab and weakening of the overall structural system.

1.12F	Concrete Bowl Patch & Repair	GSF	40,876	\$4.50	\$183,942.00
1.12G	CMU ADA Seating Reconstruction	EA	8	\$5,000.00	\$40,000.00
1.12H	Main Concourse Slab Demo & Reconstruction	GSF	24,890	\$18.00	\$448,020.00

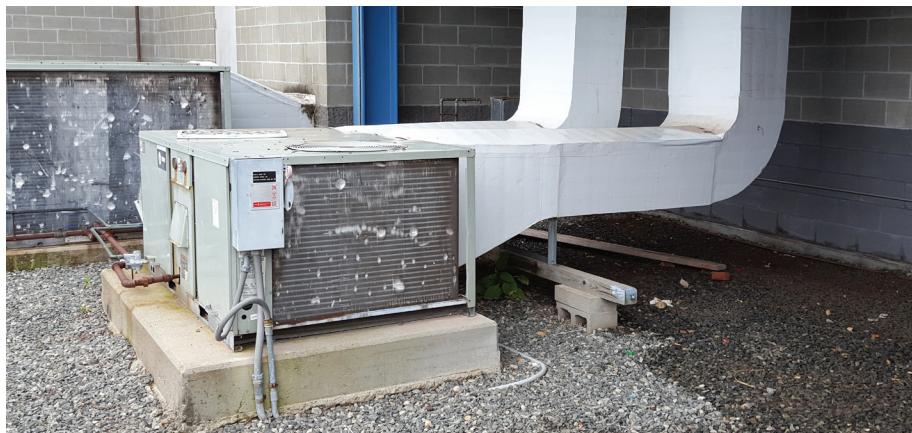
Fig. 052. Exterior Package Unit

degrees (F) or above 95 degrees. In cooler temperatures these units typically require supplemental electric heating coils. In hotter temperatures, and high humidity, heat pumps are limited to reducing air temperatures by a maximum difference of 20 degrees from the outside ambient temperatures.

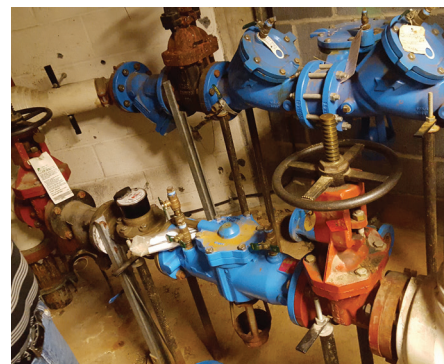
Fig. 054. Water Service Entry W/ Non-Potable Water Branch In Foreground - Note Corrosion

was reduced to 75 psig. This is per code which requires building water pressure to not exceed 80 psig in the building. Uninsulated portions of bare piping had noticeable red rust corrosion, which would be expected due to condensation (Fig. 54).

The incoming water service is subject to periodic fouling from sediment in the local utility water piping. It was reported that when the local fire station, adjacent to the stadium, performs a hydrant test or drill, this stirs up sediment which is flushed into the stadium water system. This has caused chronic problems with fixture fill valves, flush valves, and we suspect from our experience, the gas-fired water heater. The condition that causes this is not specifically known to us, but we offer as a hypothesis that this location, a former pond site, is a natural low point for the area where settling sediment would be more likely to collect in the corresponding low points of the municipal water distribution system.

the solution in our opinion would be primarily external to the building, such as a pressurized buried sediment separating tank with manhole access. Secondly, an in-building high pressure sand filter, much like a pool filter with backwash and retention, could be considered. Because the cause of the fouling is not known, these approaches are very broad in nature but with a high probability of success. We would caution on taking action on this issue without a substantially broader investigation.

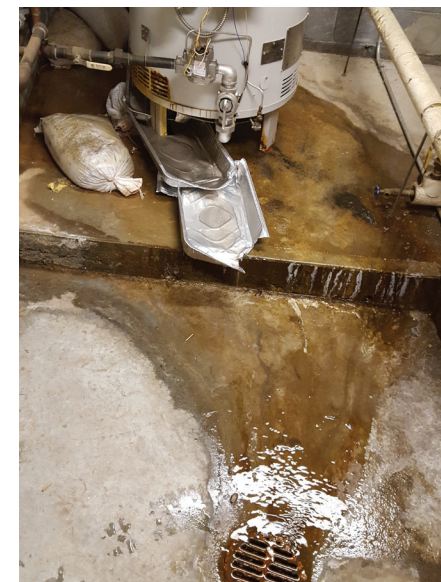
Fig. 055. Actively Leaking Domestic Hot Water Heater

Hot water is generated in the building by a model gas-fired hot water heater manufactured by A.O. Smith Berkay that was installed in 2010. The heater is actively leaking and spilling to the floor drain. We were told that replacement was to occur in the days after our visit. Being just over six years old, sediment is a possible cause of heater failure in that, depending on composition, foreign material can collect on heat transfer surfaces and create hot spots, surface boiling and cavitation pitting, in addition to general corrosion. This is simply an opinion out of experience, not

a statement of cause. We also expect it has had significant through-put duty of water to be heated. Nevertheless, we find it unusual that a heater of this nature would fail relatively early in its life (Fig. 55).

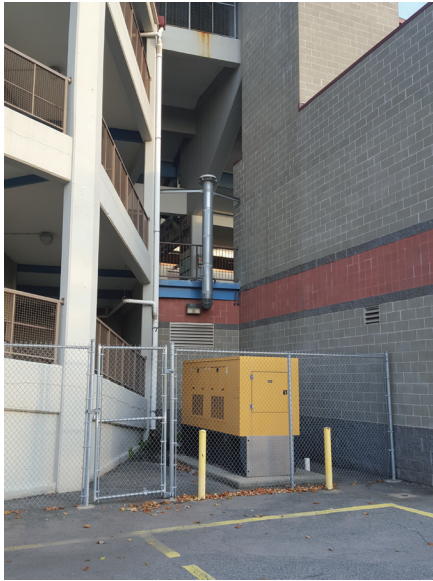
*Fig. 056. Domestic Hot Water Heater Vent Termination Below Roof And Above Walkway - Note Proximity To Generator*

The venting of the water (Fig. 56) was deficient in that it terminated below the roofline over a covered walkway. The venting was of a Type B Category I gas vent with mushroom cap. In best practice it would be conducted above the high roof or discharged horizontally away from the building with a power-vent device.

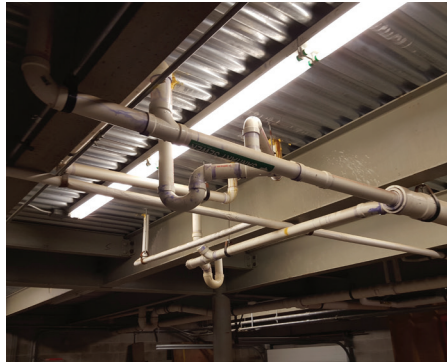
*Fig 057. PVC Plumbing Piping Exposed within The Out-Building Electrical Room*

Plumbing sanitary piping material, where visible, appears to be PVC plastic (Fig. 31). While permissible as a material per the International Plumbing Code (to which Rhode Island subscribes, predominantly, with amendments), there was at least one electric room where there was visible PVC plumbing piping from the floor above. This would violate fire separations in our opinion and would require either a replacement with an approved metallic piping system or a fire-resistive enclosure to meet the room rating.

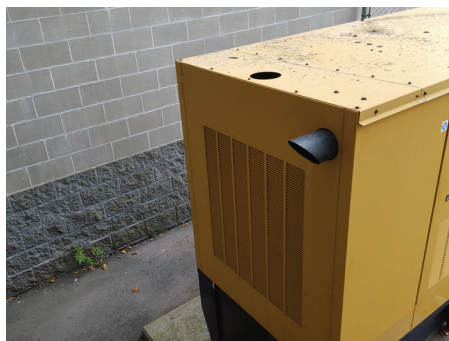
Fig 058. Generator Exhaust To Be Extended To Roof

The emergency generator is located outside in close proximity to the building (Fig. 58). The exhaust piping consists of a short section from the generator housing. This leads to diesel exhaust penetrating the building.

The emergency feeders, emergency automatic transfer switch and emergency panel are not separated from the normal power equipment as required by current electrical code.

Additionally, the automatic transfer switch is located approximately three feet from the main power switchboard and without physical separation. Current code requires the normal and emergency power systems to be in separate rooms with the emergency systems being enclosed in a 2-hour fire rated compartment room.

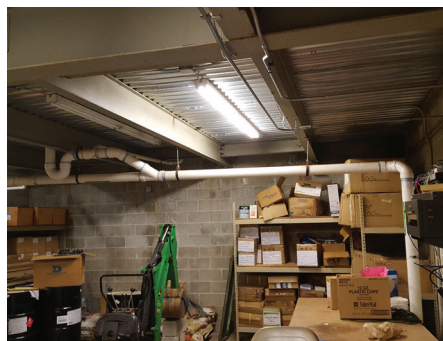
Fig. 060. Exposed PVC Piping Within The Out-Building

Condition does not meet code requirements for service access

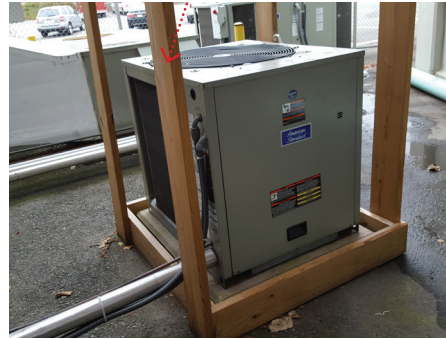
Fig. 067. Example Of At Grade HVAC Unit

Wood Frame Built To Protect HVAC Package Unit From Falling Snow From Roof Above

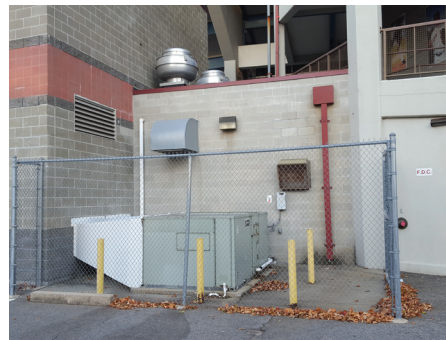
Fig. 068. HVAC Equipment Exposed @ Exterior

Exterior Equipment Exposed To Elements Invite Opportunities For Water Infiltration

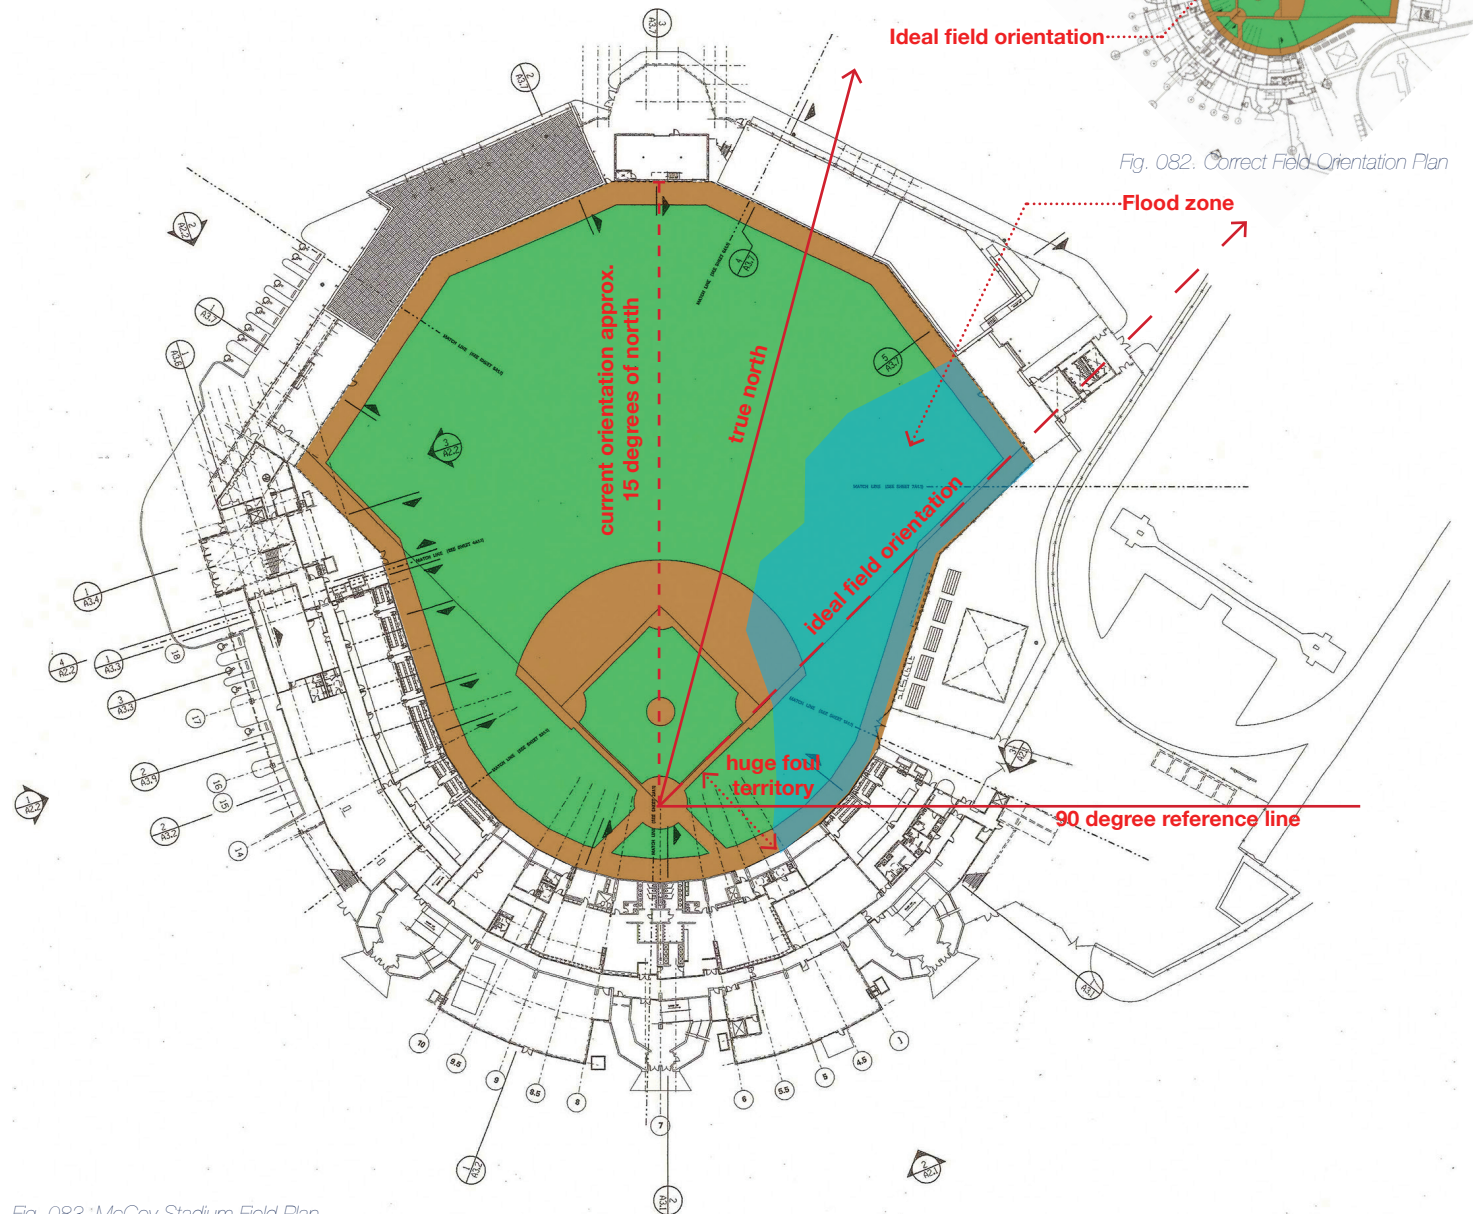
Fig. 083. McCoy Stadium Field Plan

Beginning with the playability of the field there are a couple items that immediately stand out. As illustrated by the plan drawing on the right side of the page, the field orientation of McCoy Stadium from home plate to center field is approximately 15 degrees west of true north which is typically unacceptable in modern stadium design practice. This orientation exposes the first baseman to setting sunlight in his field of view which could have a drastic effect on his ability to see ball in play. The ideal orientation that maximizes shade on the infield taking full advantage of the setting sun during evening games in the summer is a north/northeast orientation from home plate to center field. The small McCoy Stadium plan at the upper right hand corner of this page illustrates the correct field/stadium orientation that would foster the safest conditions on the field as well as the most favorable/comfortable conditions for patrons. This orientation is further explored in Part 02.

The radial seating bowl in contrast to the orthogonal geometry of the playing field which was very popular in early stadiums creates a great deal of foul territory down each base line which reduces the overall intimacy for patrons in the seating bowl.

Although this condition does not have a direct effect on the life safety of patrons or the direct useful life of the stadium, it does have a significant impact on the enjoyment of the game in contrast to what would be anticipated at a more modern ballpark.

We recommend the outright demolition, over-excavation, and replacement of McCoy Stadiums playing field in conjunction with the recommendations made in Section 1.02 (Civil Engineering & Landscape Architecture) of this report as it relates to storm sewer improvements, to resolve the drainage and irrigation issues currently being experienced. This replacement shall also include technology upgrades to accommodate modern monitoring and control protocol in line with similar facilities constructed in the last ten (10) years.

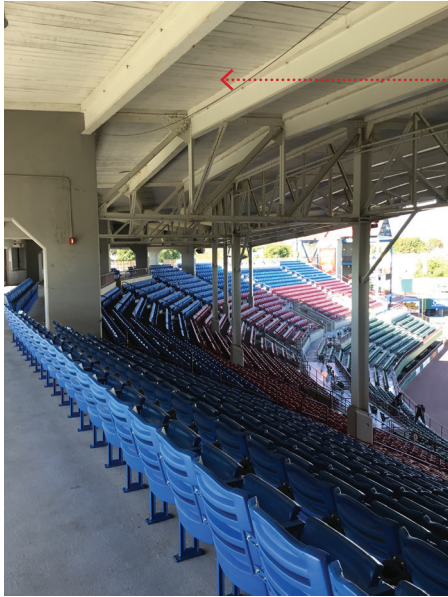
Fig 095. 1942 Seating Bowl Behind Home Plate

The McCoy Stadium seating bowl is comprised of 3 separate sections serving the majority of patrons during games. The 1942 portion is located directly behind home plate and is covered by a tongue-in-groove wood roof that provides shade and weather protection for approximately 75% of the seating bowl.

While the roof does a great job of shielding patrons from inclement weather, it also presents a few areas of concern that we feel warrant further discussion. As it relates to long-term upkeep for the next twenty years, there are a number of boards throughout the roof that require patch, repair, and/or replacement. This presents a rather expensive issue because the lumber used is not a standard nominal dimensions as is readily available

Sparse lighting fixtures beneath the main roof causes safety concerns for patrons during emergency egress

at common lumber yards. Instead it is a true dimensional lumber that must be custom cut to fit each application. We also noticed a number of areas where the painted surface is starting to peel which leads us to believe that exposure to inclement weather and water infiltration is a fairly uniform issue. The only way to resolve this issue is expose the area of water infiltration on the outer face of the roof assembly and uniformly patch the damaged area. This action shall be followed by scraping away damaged and peeling surfaces down to the raw wood material and then prime and paint the entire surface with a commercial grade high weather resistive primer followed by several coats of a finish paint.

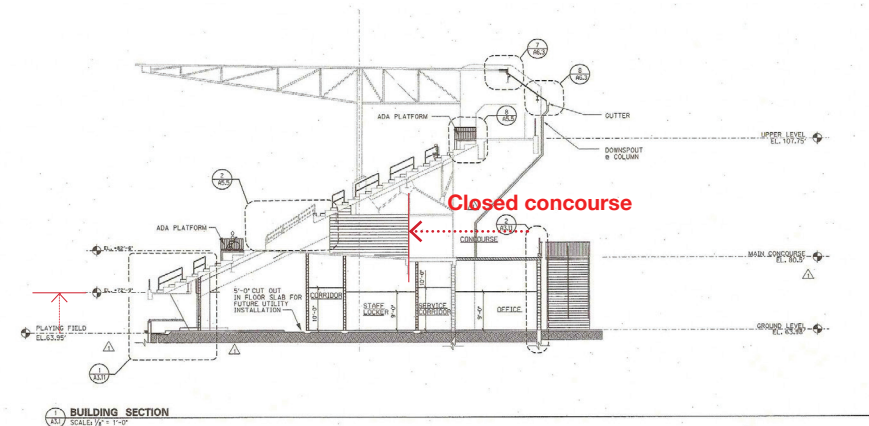
Fig. 100. McCoy Stadium Typical Building Section

The configuration of the 1942 seating bowl which set the precedent for the new seating bowl installed in 1999 is a "closed concourse". This condition is illustrated in the McCoy Stadium typical building section on the upper right hand corner of this page. Patron circulation occurs behind the seating bowl and hospitality areas such as public restrooms and service areas are tucked beneath very similar to an indoor arena. This is a very common structural configuration for seating bowls in stadium of this era however, the key disadvantage is the fact that it cuts off the visual line of site of patrons to the field of play when they are circulating the concourse in search of concessions and/or other hospitality services.

In contrast, the first row of seating at McCoy Stadium is elevated approximately 9'-0" above the playing field surface - very similar to what would be traditionally designed for a football stadium with the intent of providing clear lines of sight over the shoulders of standing players at the side line bench.

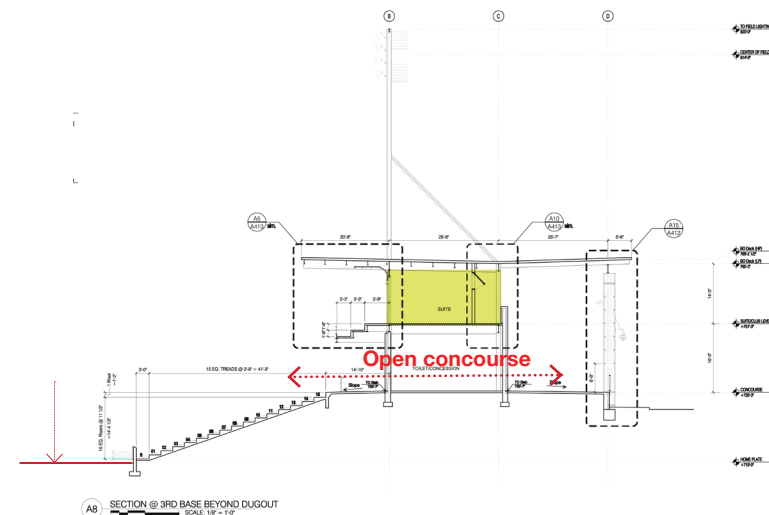
Fig. 099. Modern Ballpark Building Section

Common practice in modern ballparks in similar markets within the past ten (10) years is the "open concourse" configuration illustrated in the Huntington Park Class AAA building section on the lower right portion of this page. In this configuration premium amenities are raised above the concourse by structural steel columns, hospitality and food service program is pushed to the perimeter secure line, and the first row of the seating bowl is pushed all the way down to the playing field surface. This seating bowl configuration creates a much more intimate setting for patrons that allows them to circulate the concourse and maintain a visual connection to the field of play at all times. This configuration adds to the excitement of the game.

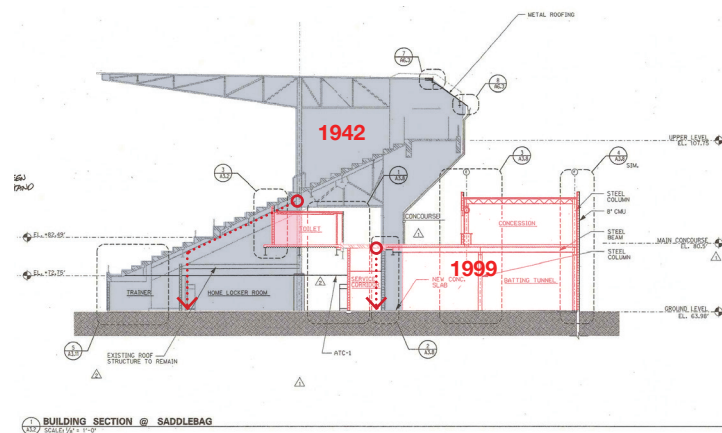
Fig. 101. McCoy Stadium Building Section

There are also a number of hand rails, and broken fixed seating assemblies that require immediate replacement or repair to comply with code required life safety regulations.

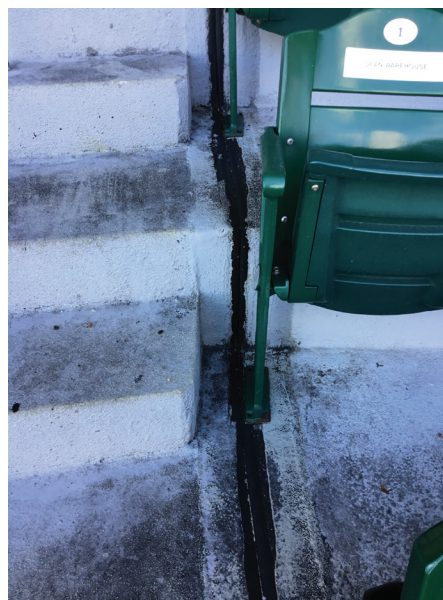
Fig. 102. Seating Straddling Expansion Joint

The most substantial condition that has caused a great deal of water damage in the field level suites down the third baseline is the expansion joint that exists between the original 1942 structure and the 1999 renovation. Fig. 106 illustrates its condition that is complicated even further by fixed seating elements that straddle the joint. Fig. 108 illustrates the field level suite on either side of the expansion joint between buildings. On several of our visits to McCoy Stadium including the day of our interview, the ceiling as well as the carpeted floor were saturated with water due to failure in the expansion joint assembly coupled with our hypothesis of continuous shifts in the independent structure that may very well exceed the limits of the joint assembly.

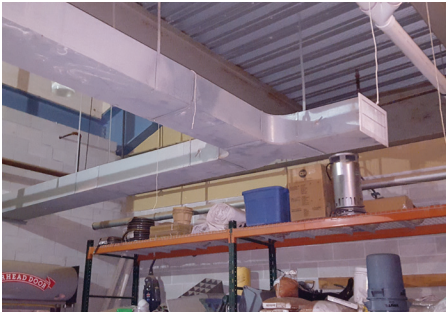
Fig. 112. Promotions/Retail Storage Room

The primary "grounds storage" area at McCoy Stadium is located directly adjacent to the visiting team dugout on the first base line and is approximately 288 SF (lower right plan). The room is accessed through a six (6) foot wide metal roll down door that opens directly to the warning track. The grounds storage room is also adjacent to "promotions/retail storage" that is approximately 1,440 SF. The primary function of this space is to provide ready access to promotional materials needed for between inning on-field promotional entertainment (i.e. games, mascot materials, etc.)

The current space was originally intended for other uses however during the 1999 renovation the groundskeeping program was not included in the project. Due to the small size of the "grounds storage" room in comparison to similar current facilities, the "promotions/retail storage" is used interchangeably with "grounds storage", which presents a number of operational inefficiencies, placing the tenant at a severe disadvantage in consideration of the fact that the playing field surface is the most important element of the stadium... if there's no field, there's no game, which decreases the likelihood of the presence of patrons.

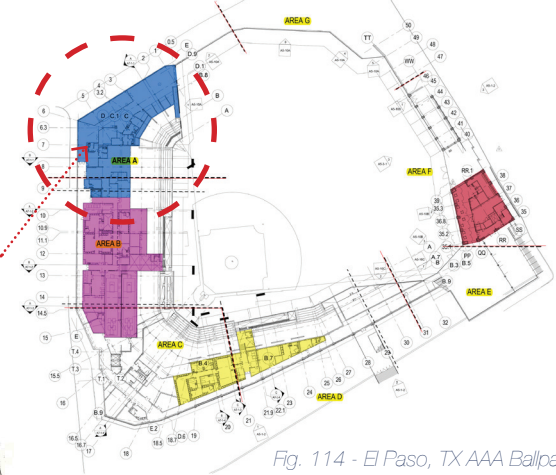
Fig. 114 - El Paso, TX AAA Ballpark Plan

Groundskeeping & Operations Area At Average Modern Ballparks Is Approximately Four (4) Times Larger Than McCoy

A floor plan of the "grounds storage" and operations wing of Southwest University Class AAA Ballpark in El Paso, TX has been provided on the previous page to illustrate the spacial difference between it and McCoy Stadium. You'll note that the soil bins are located at the interior of the building and are directly adjacent to an interior holding area for tractors, mowers, and other related field equipment. In addition, adjacent program areas include a workshop area for service and repair of items on site, operations staff lockers and toilet area, general storage, dedicated MEP equipment rooms, indoor storage for the batting shell, and a spacious receiving/loading dock area.
