# MCCOY STADIUM Study

January 26, 2017

Pawtucket, RI

## FINAL REPORT

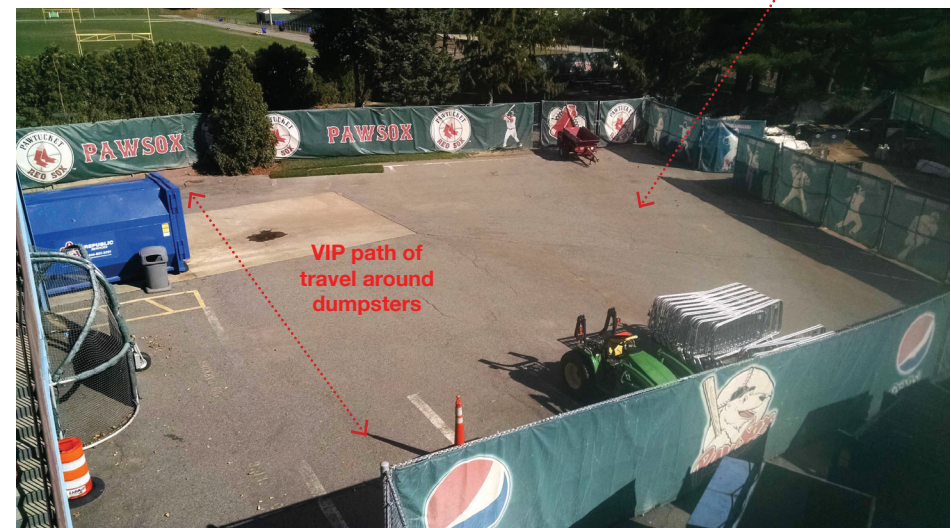
Fig. 117. Exterior Grounds Storage

In Section 1.34 (Grounds Storage & Operations), page 48, Figure 117 identifies an issue that currently exists that from an operational standpoint is unacceptable. VIP patrons circulating from the grade level suites to the VIP tent down the first

Excess soils, warning track materials, and sand for use on the field is located at an exterior storage site near the dumpster area and VIP tent further down the first base line. Tractors, mowers, and other field utility equipment are also temporarily stored in this exterior area due to lack of suitable interior space. Although this area is fenced in as illustrated by the photo at the bottom right of this page, it is not secure and therefore not suitable for long-term storage. At the conclusion of events most of the field maintenance equipment is relocated to the "grounds storage" room illustrated on the previous page.

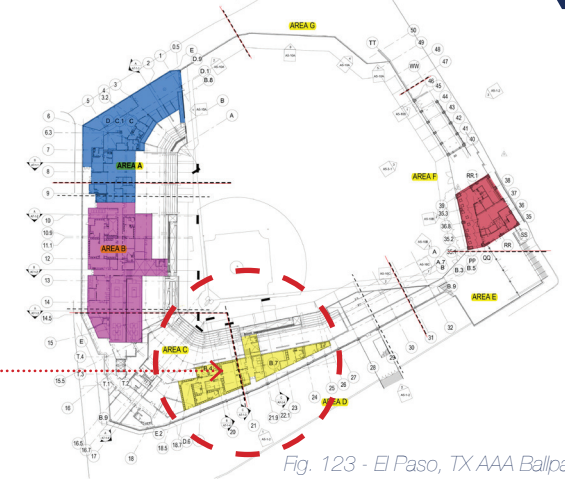
Fig. 123 - El Paso, TX AAA Ballpark Plan

Fig. 119 - 123 illustrate the difference in square footage between McCoy Stadium and Class AAA Southwest University Ballpark located in El Paso, TX constructed in 2014. The comparative square footage areas are as follows:

McCoy Stadium	5,121 SF
El Paso	6,685 SF

El Paso is approximately 24% larger

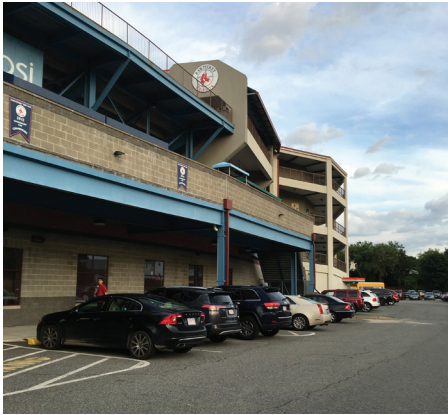
Fig. 124. Administration Offices Exterior

The team administration space at McCoy Stadium was added primarily during the 1999 renovation and is represented in the floor plan on the right side of this page by the yellow colored area. You'll note that one of the field level suites has also been included in the administration designation due to the lack of enclosed office and conference room square footage.

The overall condition of the interior space is consistent with what we'd anticipate for a building constructed in 1999 however, issues with water infiltration have played a significant role in damage to ceiling finishes and floor covering which requires immediate resolution.

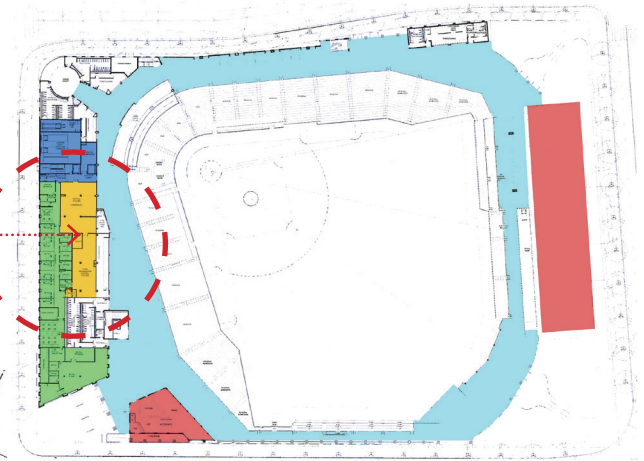
Fig. 132. Charlotte, NC AAA Ballpark Plan

McCoy's commissary storage area is roughly 40% smaller than the average Class AAA ballpark as illustrated by the example of BB&T Ballpark located in Charlotte, NC (Fig. 132). While McCoy's commissary only serves as primary storage (and old mechanical equipment dated prior to 1990), most ballpark commissary storage spaces in similar markets and of similar scale built within the last ten (10) years include central cooking areas

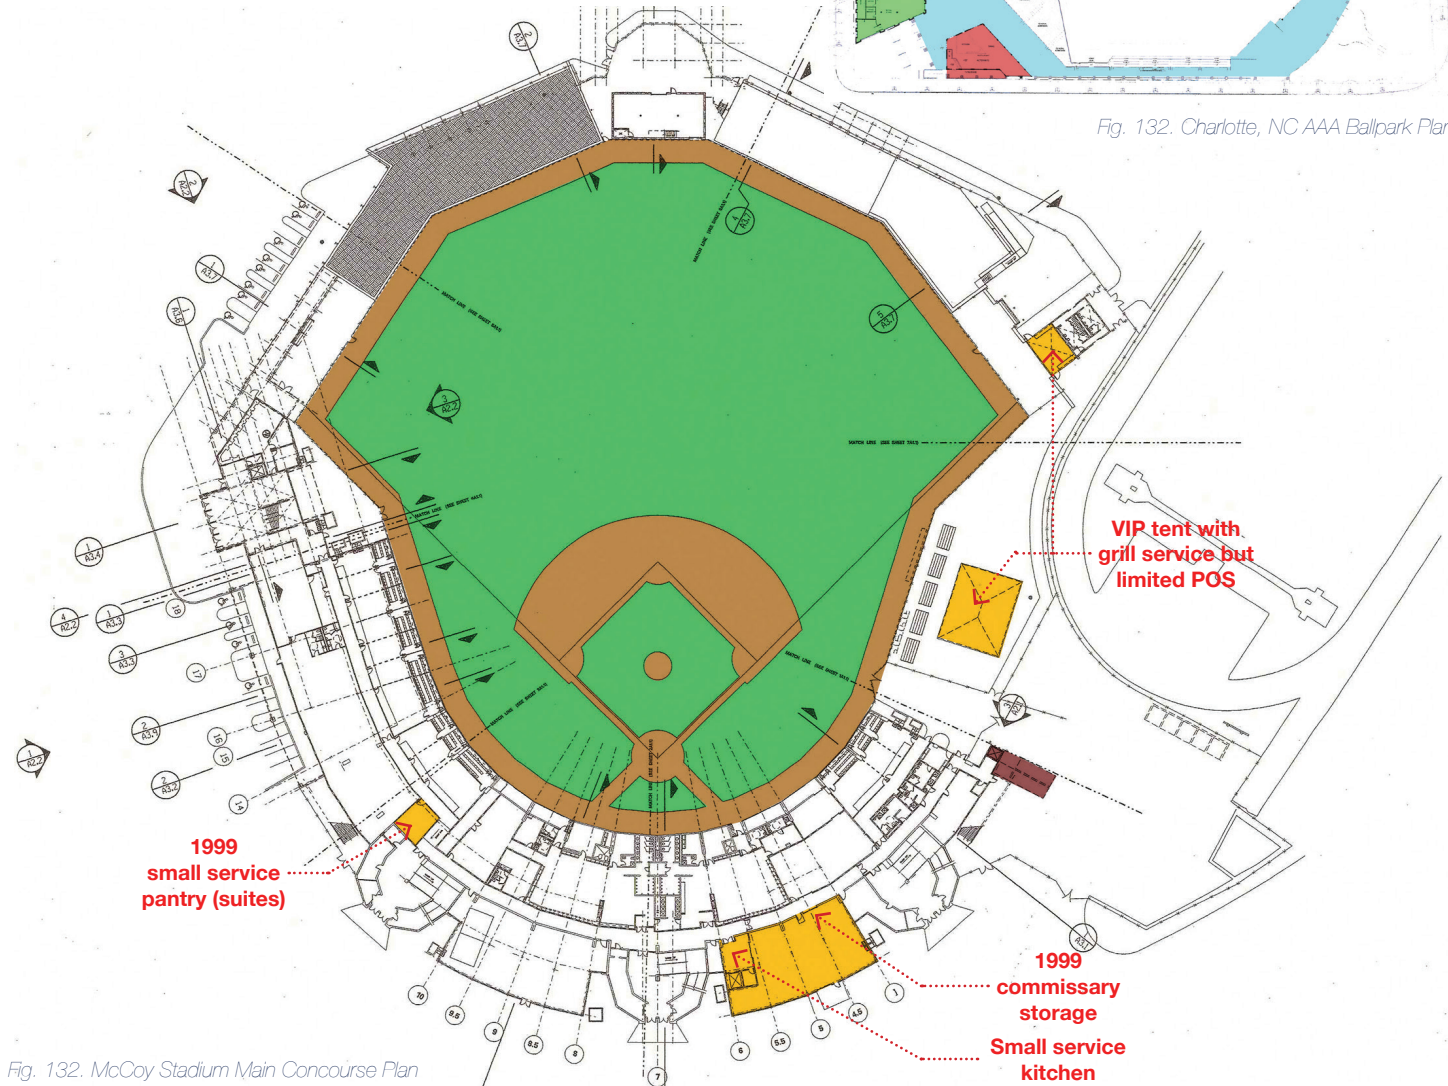
Fig. 132. McCoy Stadium Main Concourse Plan

The food service operations at McCoy Stadium were significantly revamped during the 1999 renovation. One of the key improvements was the addition of a commissary storage area (central clearing house for dry goods, beer keg coolers, and frozen goods) just to the right of home plate along the outer edge of the building (approximately 3,350 SF). It is served in theory by a service elevator, however its use has been limited due to overheating and malfunction as described in Section 1.21 (MEP & Technology).

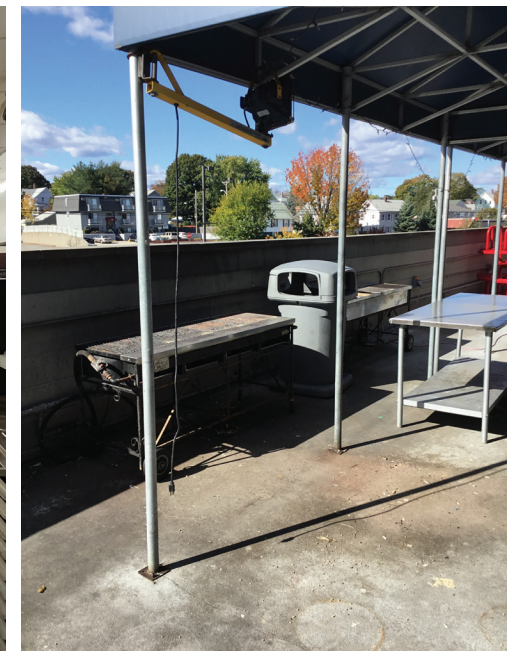
Fig. 136. Concourse Terrace Grill - No Cover

- Expand/replace roofing over concession terrace grilles (Fig. 135) is recommended. Typically the health department requires grilles to be covered to prevent insects and other flying objects to contaminate food.
- Application of sanitary traffic coating at concession terrace grilles is recommended (Fig. 135). This is typically required by the health department at cooking areas.
- Addition of power is recommended to serve the outfield amenities. Currently both power and data is severely limited to these areas, and there is concern that lighting levels do not meet minimum requirements.
- Establishing a uniform and digital menu board system is highly recommended which will allow the ability to modify pricing structure and offerings digital and on an event-by-event basis.

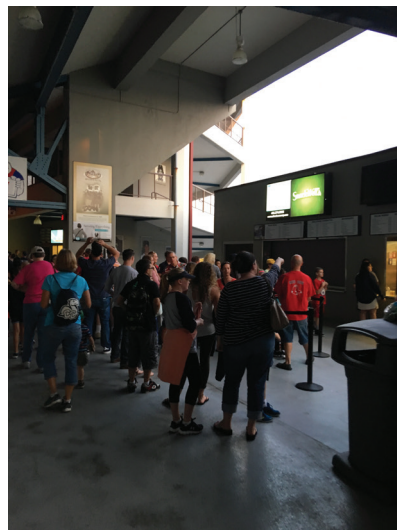
Fig. 160. Narrow Concourse - Long Lines

During our visit to the ballpark on several occasions our representatives waited in rather long lines for food & beverage (this will be further addressed in Section 1.39 of this report), only to find that once we arrived at the front of the queue the stand was out of service items (hot dogs at one location, particular beer at another location). While understandable this was a very off-putting situation that can be easily addressed with a digital menu board system as recommended above.

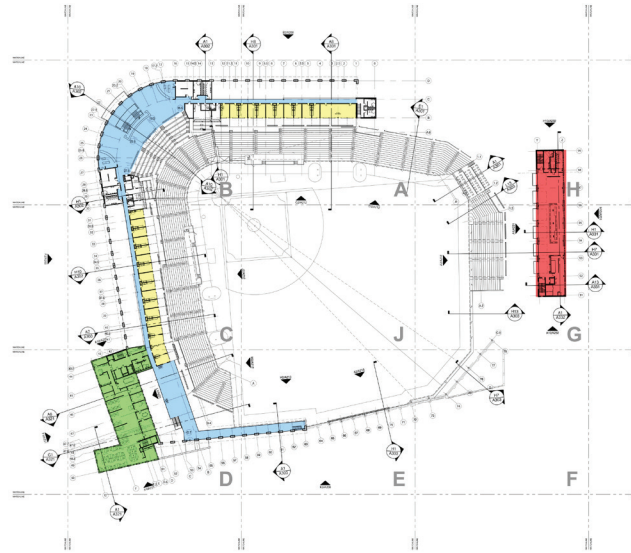
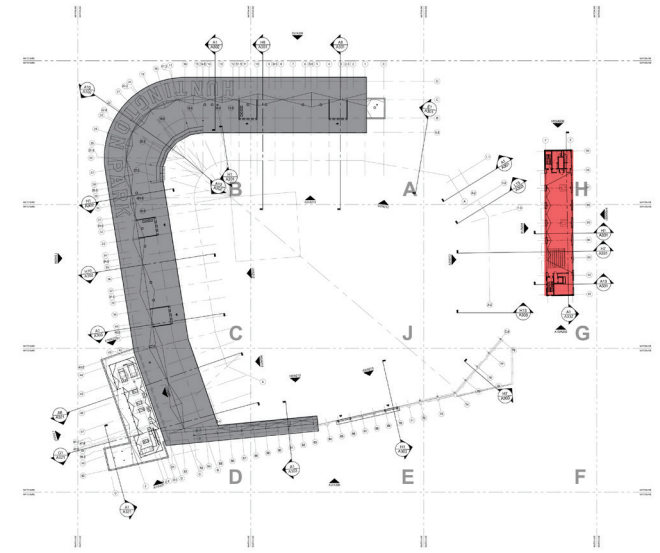
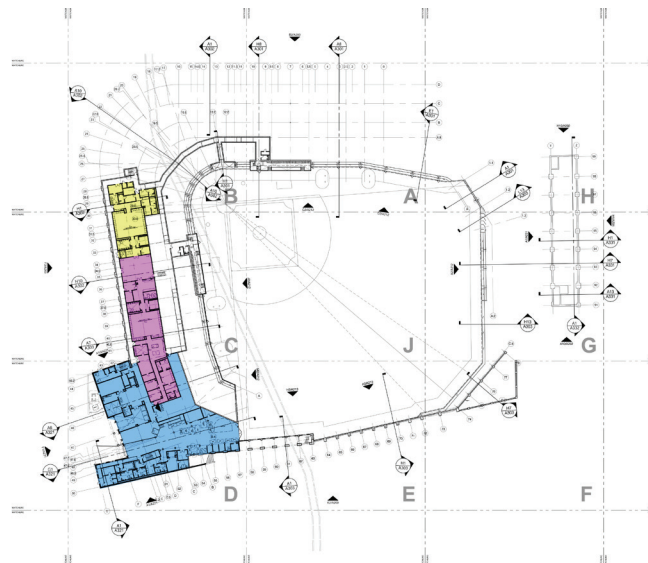
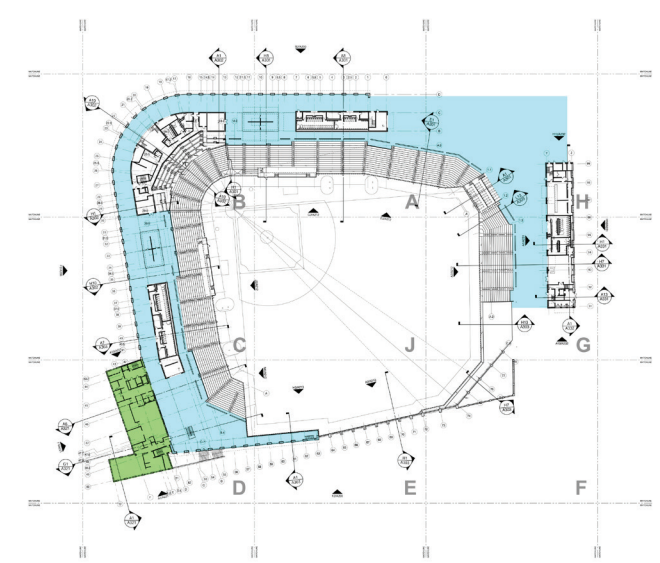
Fig. 200. Suite Level Plan

- The overall floor plates for Huntington Park are well organized with very efficient stacked masses.
- The red colored area in Fig. 200 represents a three (3) story building that can be rented on game-days but more importantly presents an opportunity for future occupancy of a lease tenant with views into the ballpark.
- The main concourse is at street grade and is very spacious (Fig. 201).
- The minimalist approach of the premium concourse level (Fig. 200) allows ample room for circulation while minimizing the building footprint.

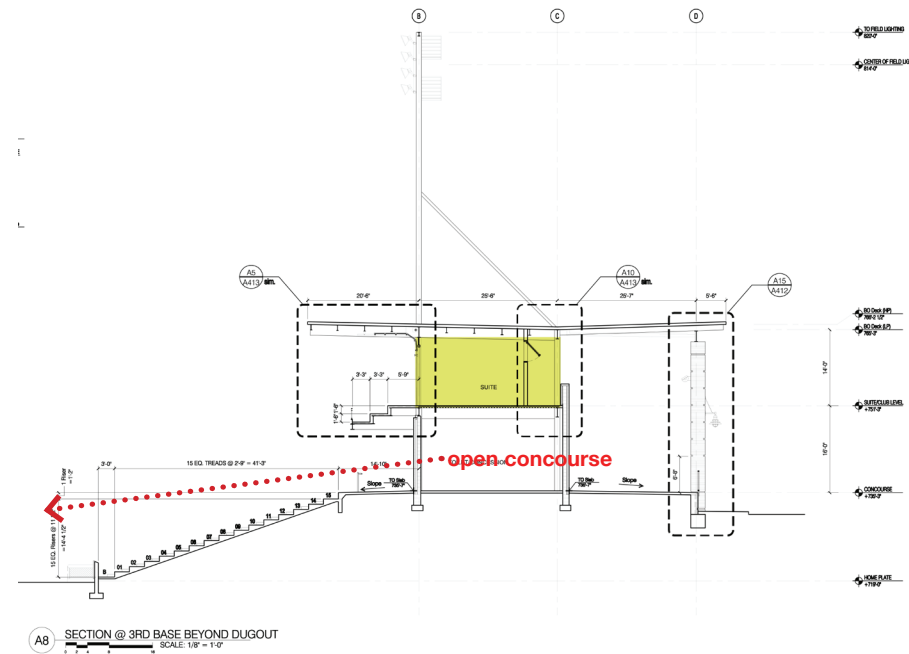
Fig. 204. Huntington Park Building Section

One of the unique features of Huntington Park is the overall scale of the building. The ballpark is very low to the ground with a very simple but powerful superstructure.

The departure from the traditional seating bowl behind home plate with the development of open air loge boxes offers a semi-premium amenity in an area that is perceived to have the best seats in the house. The result is a very unique energy behind home plate that we can't say we've experienced at any other ballpark.

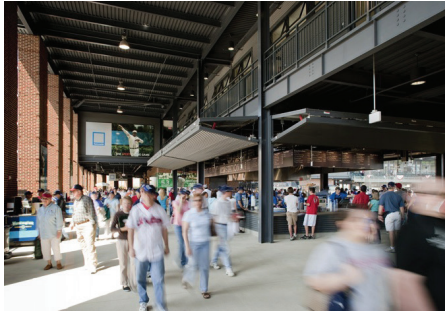
Fig. 207. Spacious Concourse & Unique Concessions

The very industrial feel and articulation of steel in form and color as well as the very raw materials used even in high finish areas provides an interesting departure from what many would consider "standard fare" in a ballpark (Fig. 207).

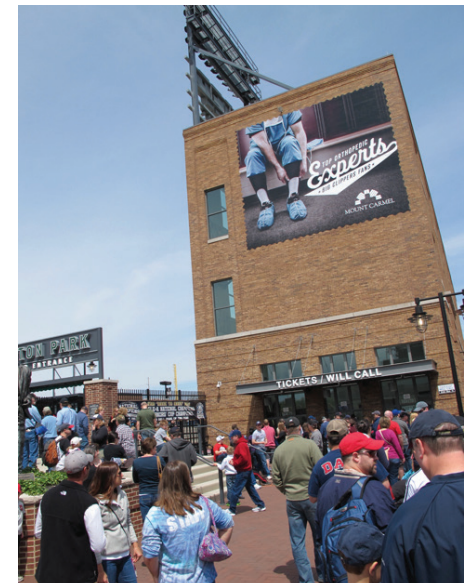
Fig. 211. Outfield Rental Building

Huntington Park offers a timeless architectural style that is reminiscent of classic ballparks while still pushing the envelope on what many would describe as "modern". There is a very deliberate uniform branding style that unifies the ballpark from all angles (Fig. 211).

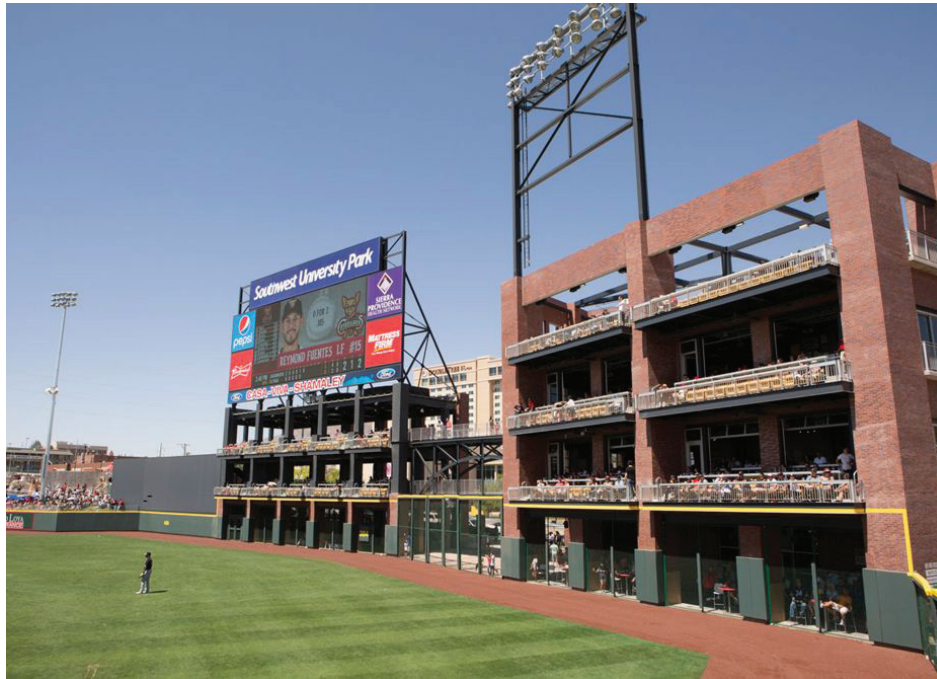
Fig. 220. Right Field Porch & Rental Spaces

Southwest University Park is massive in scale and amenities. Its "double-sided" perimeter in right field with the four story building that also provides a measure of transparency at the street level is nothing less than cool (Fig. 220).

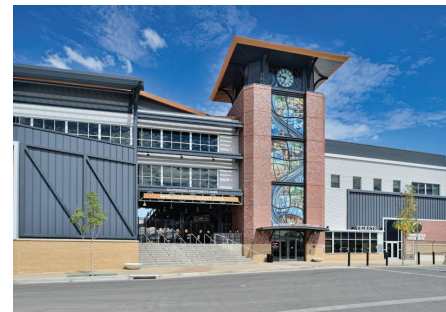
Fig. 221. Home Plate VIP & Administration Entry

The ballpark's local feel at the VIP entry (Fig. 221), which is only a block or so away from neighborhood bars and cantinas (well within walking distance), encourages pre and post-game support of local business and entertainment.

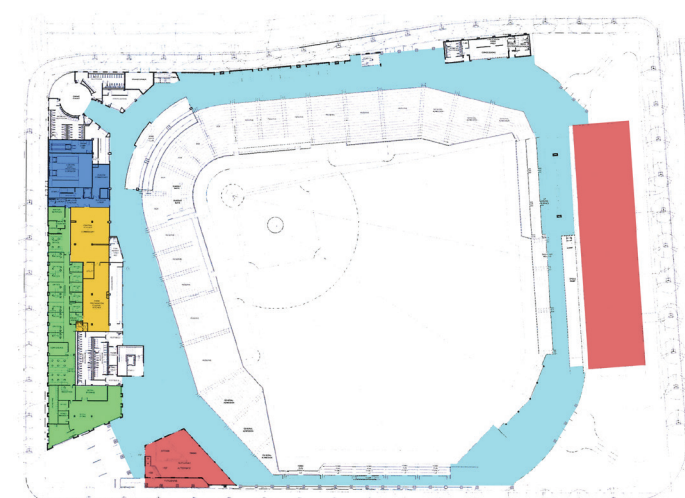
Fig. 226. Main Concourse Level Plan

One of the key advantages of BB&T Ballpark in addition to being located in a redeveloping downtown area is the very strategic planning of pad sites with views into the ballpark for future development. The areas in red on Fig. 226 illustrate retail pad sites that compliment the very urban feel of the ballpark.

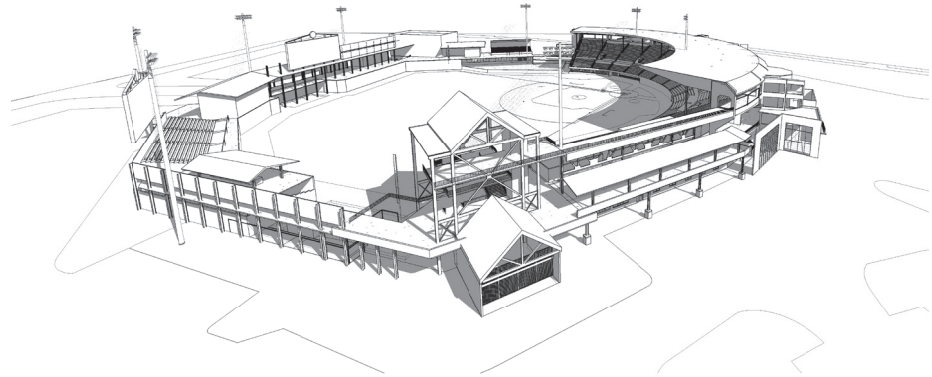
Fig. 238. McCoy Stadium Renovation Concept Aerial

- Beer gardens added at concourse level (outfield right/left).
- 12 skyboxes added adjacent to press area.
- Press box expanded.
- Grandstand relocated/replaced - left field.
- The existing football field and track shall be demolished and expanded for use as 300 additional on-site parking spaces.
- Approximately 25 parking spaces for dedicated team administration use have been located adjacent to the new team store/administration/ticketing building in right field.

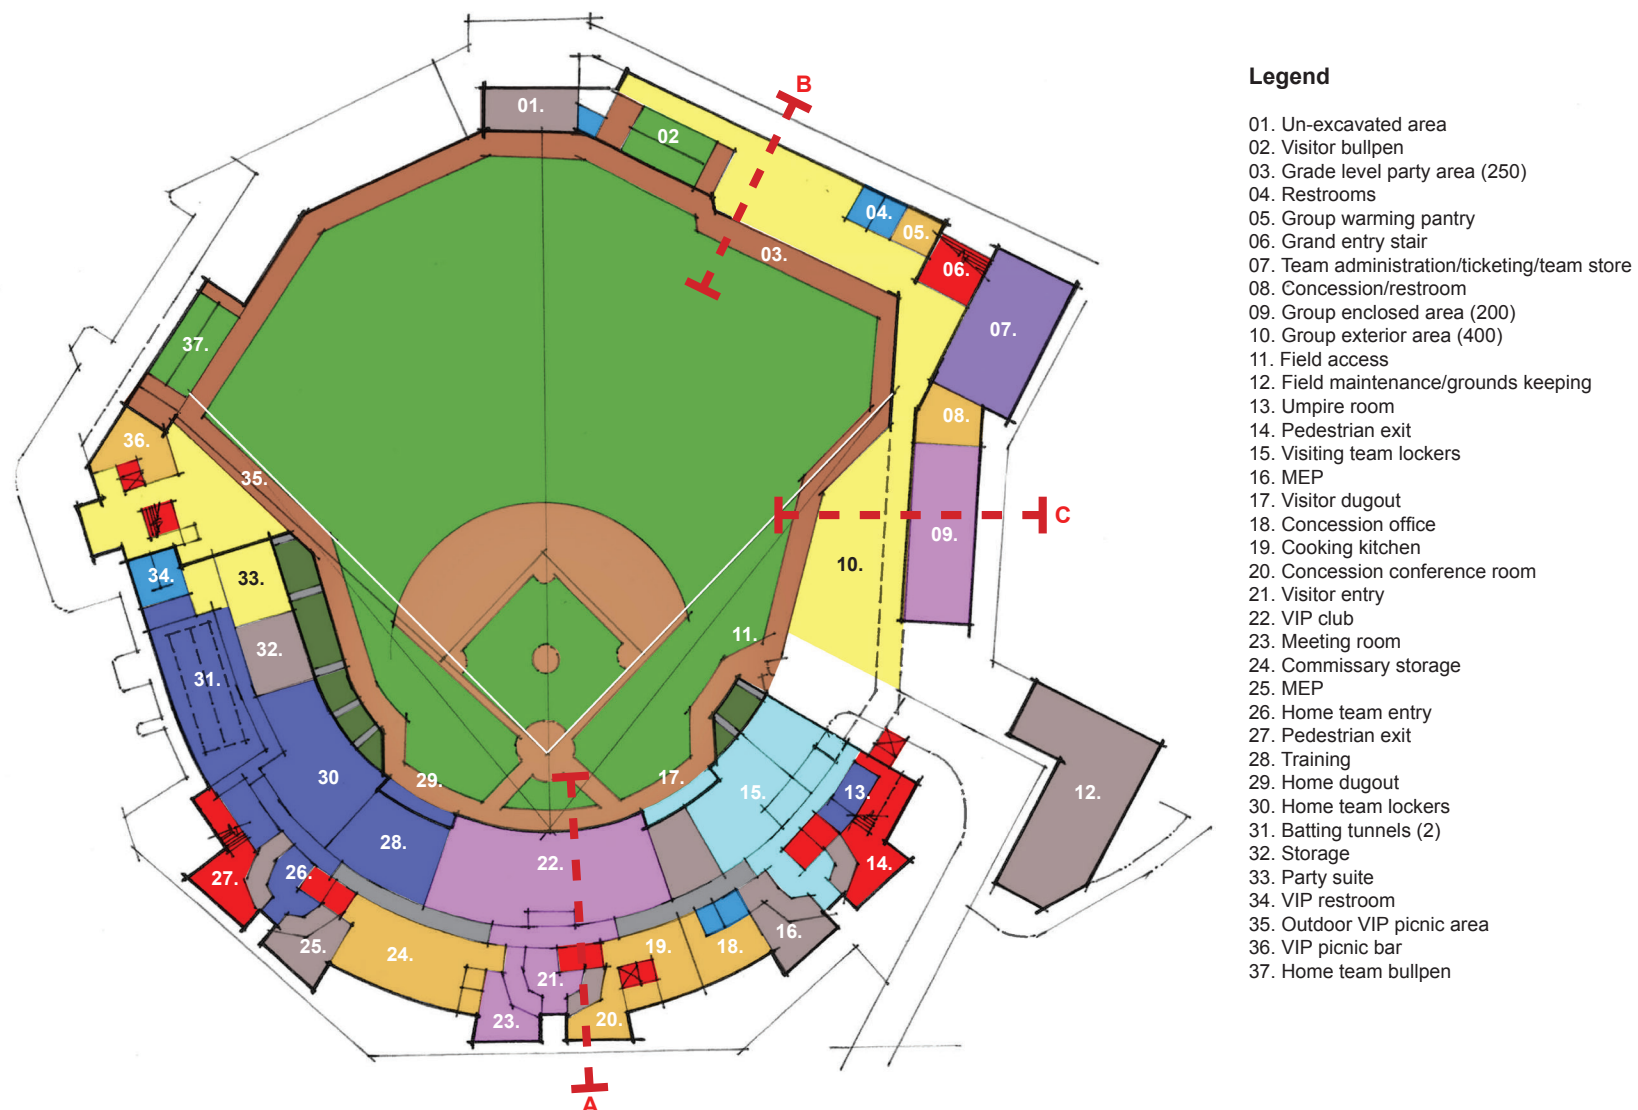
McCoy Stadium - Pawtucket, RI : Renovation Concept - Grade Level Plan

As illustrated in the Ground Level Plan Fig. 239 we have proposed a complete reorganization/expansion of enclosed operations program space. This reorganization includes expansion of commissary storage and kitchens, relocation of the home and visiting team clubhouses, and the addition of an enclosed premium club (22.) behind home plate that will accommodate VIP dining during games and large group meetings, weddings, etc. in non-game day conditions. The existing circular ramps will be screened at grade level to conceal mechanical equipment. The towers will also be enclosed at the above grade levels continuing their tradition as historic memorabilia display cases, only in a much more elegant way. The problematic trash enclosure (12.) shall be relocated to the far left and combined with an expanded field maintenance and building operations workshop.

Ticketing, the main merchandise store, and team administration (0.7) shall be relocated to right field, much closer to the main pedestrian flow from adjacent on-site parking lots and remote parking north of Division Street. The "VIP Tent" shall be converted to an indoor/outdoor premium hospitality area (09., 10.) still down the right field line and shall be accommodated by new restroom and concession/food service facilities. We have modified the overall geometry of right field, intentionally making it more asymmetrical and allowing room for an at-grade picnic pavilion with direct views to the field. The entire playing field surface shall be rebuilt including the sub-grade drainage system. All parking

shall receive upgraded storm systems to prevent flooding, and shall be resurfaced and striped. The existing football/track field down the right field line shall be demolished and re-purposed for use as additional parking (300 new spaces).

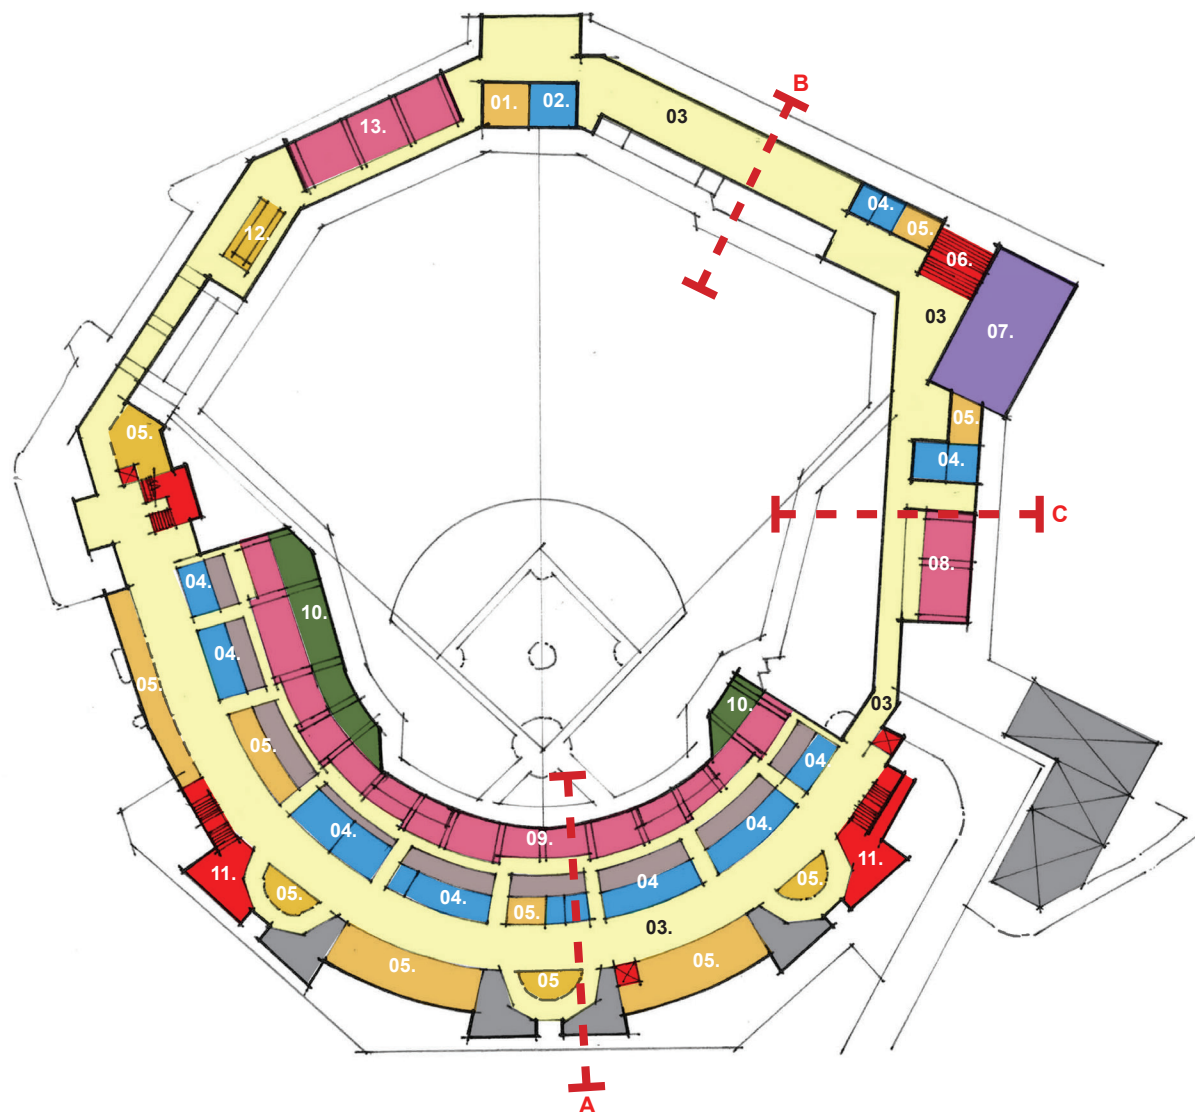
McCoy Stadium - Pawtucket, RI : Renovation Concept - Main Concourse Plan

The main concourse level, Fig. 240 will be reconstructed to remove the threat of water infiltration to the occupied areas below. Portions of the seating bowl behind home plate - specifically the first and third base lines (10.); shall be extended down to the playing field surface to increase intimacy and reduce foul territory. The main concourse shall be bridged/extended to the outfield so that there is truly a 360 degree wrap around concourse (03.). Patrons will now be able to circulate the entire stadium without walking down the stairs to the grade level. New grandstands (08., 13.) will be placed at strategic locations in the outfield for general admission (GA) and overflow seating. New outfield features at the team administration suite (07.) include a grand stair that shall act as the new sponsored main entry. New bar areas (05., 12) will create themed vantage points while in the stadium.

- 01. Existing concession
- 02. Existing restrooms
- 03. Elevated party deck (200)
- 04. Restrooms (M/W)
- 05. Concession
- 06. Grand entry stair
- 07. Team administration
- 08. Grandstand 01
- 09. Existing seats (re-seat)
- 10. New seating (decrease foul territory)
- 11. Pedestrian exit
- 12. Beer garden/bar
- 13. Grandstand 02

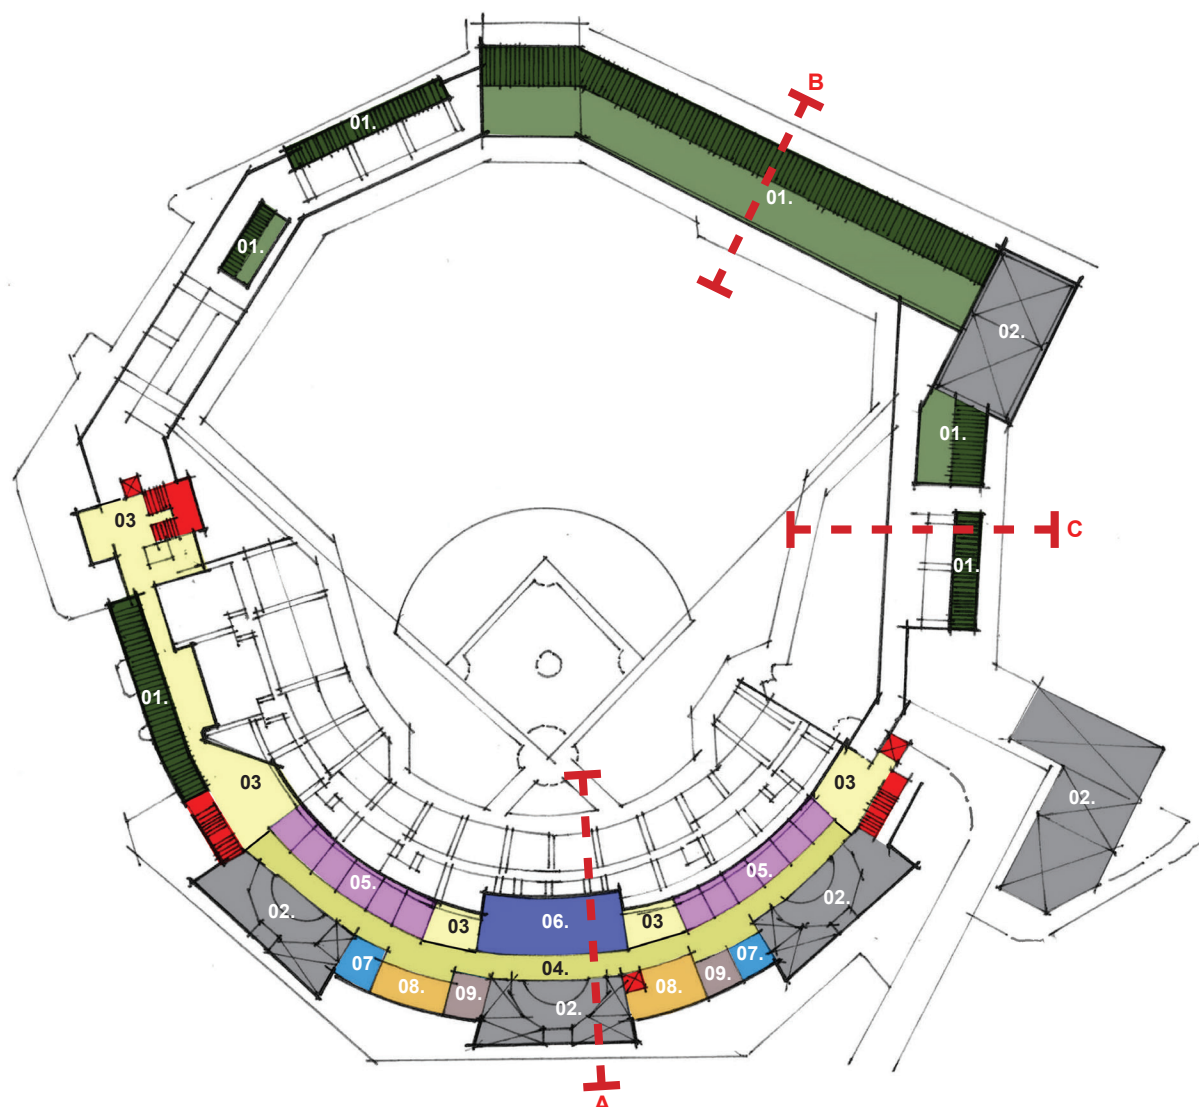
McCoy Stadium - Pawtucket, RI : Renovation Concept - Upper Concourse Level

The upper concourse level, Fig. 241 shall serve as a new premium concourse with enclosed premium suites (05.) and an expanded press box (06.). Open air party decks (03.) shall also serve as interesting in-between spaces for premium patrons at this level. Food service (08.) and restroom facilities (07.) shall be incorporated on this level served by a new enclosed premium corridor (04.) which will protect premium patrons and the press from inclement weather. The entire outfield party area (01.) shall be covered and will serve as the foundation for signature double-sided advertising/sponsor panels visible from the exterior, identifying McCoy Stadium as the place to be in the City of Pawtucket.

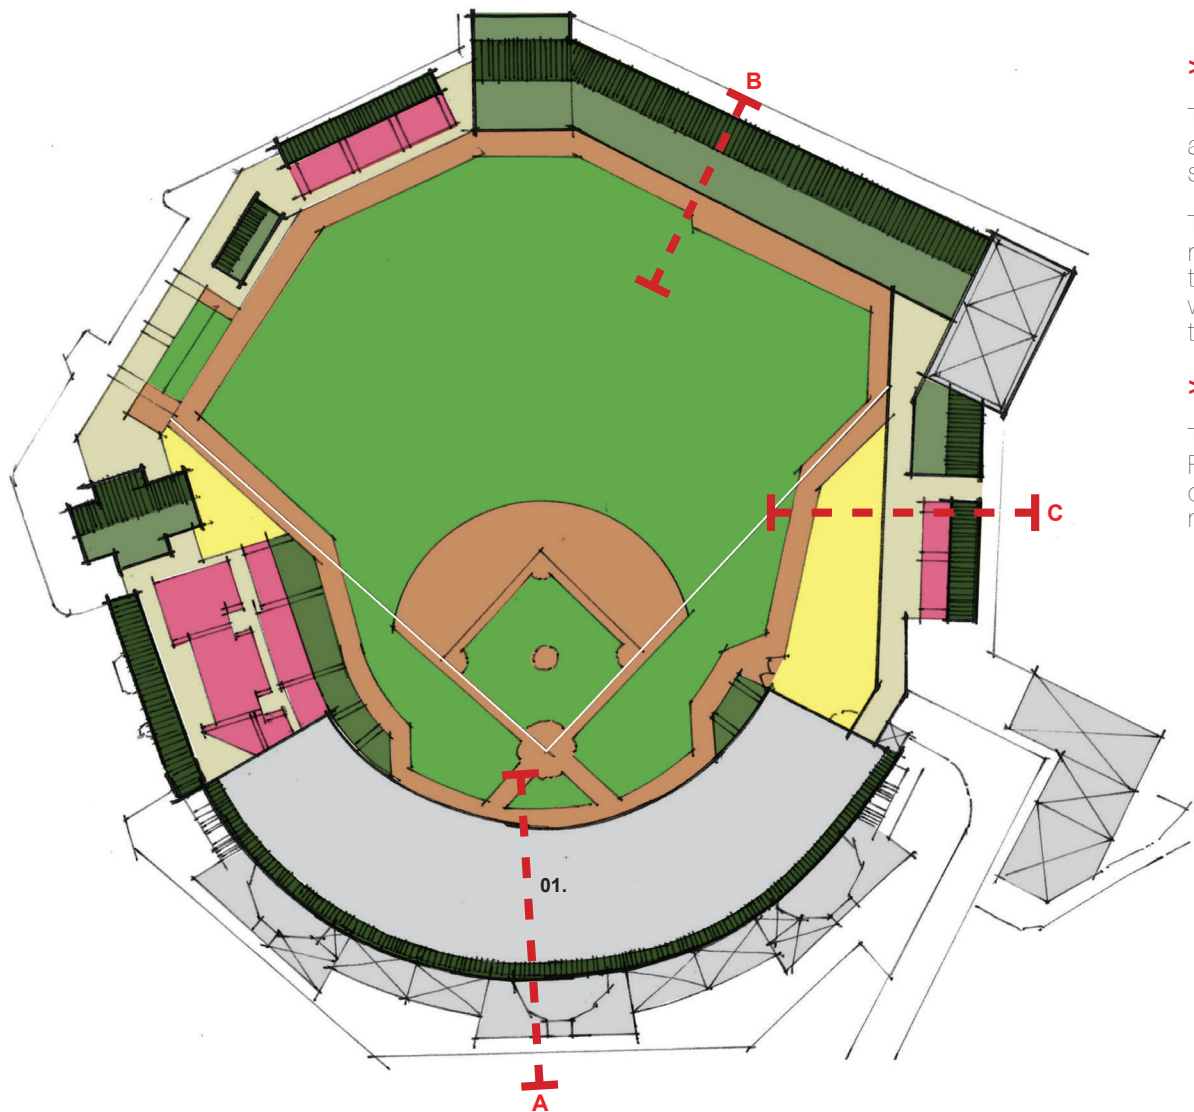
McCoy Stadium - Pawtucket, RI : Renovation Concept - Roof Plan

The roof plan, Fig. 242 illustrates the amount of new covered area that shall serve the patrons of McCoy Stadium.

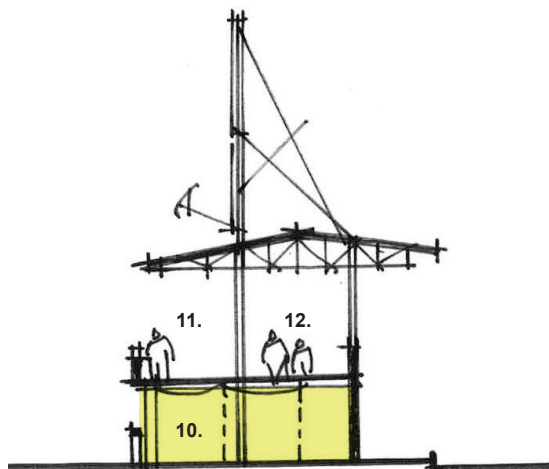
Section B - Outfield Party Deck

- 01. Home plate club
- 02. VIP circulation
- 03. Meeting room
- 04. Existing restroom
- 05. Concourse
- 06. Concession
- 07. Concession/storage
- 08. Enclosed corridor
- 09. Press box
- 10. Grade level picnic/party area
- 11. Elevated concourse party zone
- 12. Bar
- 13. Right field picnic area
- 14. Enclosed pavilion
- 15. Elevated concourse/drink rail view area
- 16. Grandstand

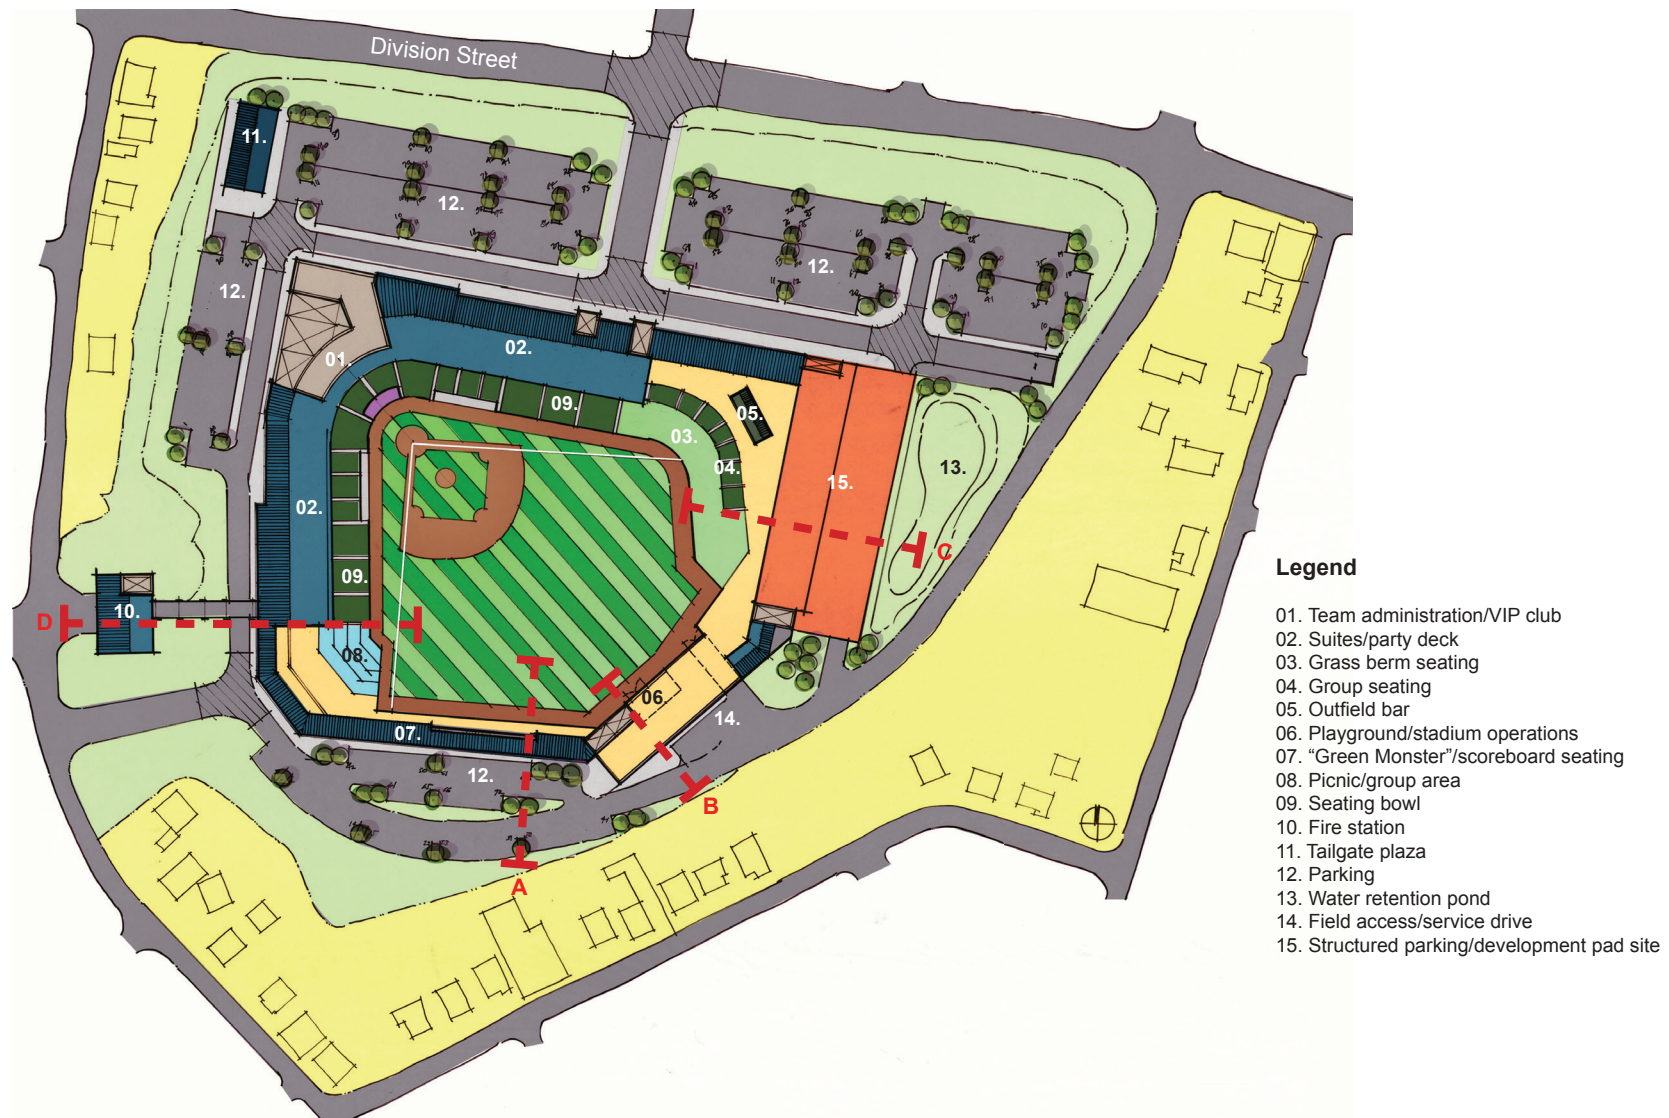
McCoy Stadium - Pawtucket, RI : New Stadium on the McCoy Site Concept

As illustrated in the overall site plan Fig. 251, the new construction option proposes all of the amenities and offerings found in a modern ballpark. The geometry of the seating bowl (09.) is very intimate and connects the elevated main concourse to the grade/field level. Surface parking (12.) still runs parallel to Division Street; however, structure parking and development pad site (15.) has been proposed in left field with direct views into the ballpark. While this option still accommodates the existing multi-family and single family housing that surrounds the southern and western perimeter of the site, the new alignment with Division Street provides a "front door" that has the potential to foster energy or a "spark" at the McCoy Stadium site.

- 01. Press box
- 02. Right field "Green Monster"
- 03. Development pad site
- 04. VIP entry
- 05. Left field entry
- 06. Scoreboard
